Dealer Word Track

It has come to our attention that your dealership recently received some '14 Model Year Camry and/or Avalon (s) that may have a lower control arm on the left front suspension that may have been mis-stamped during the assembly process.

## CAMRY/AVALON FRONT SUSPENSION INSPECTION

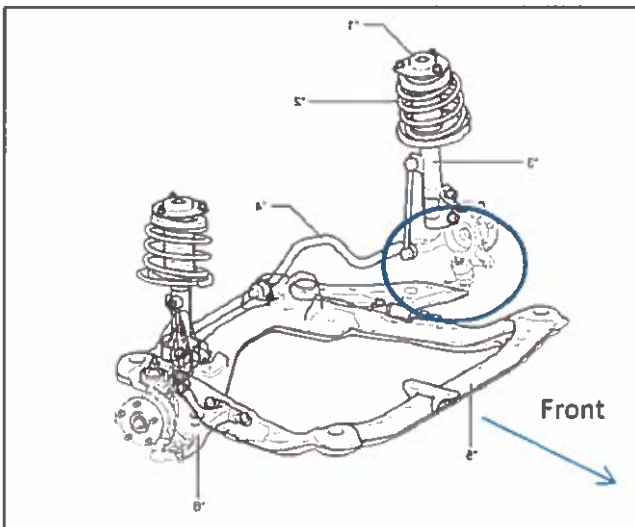
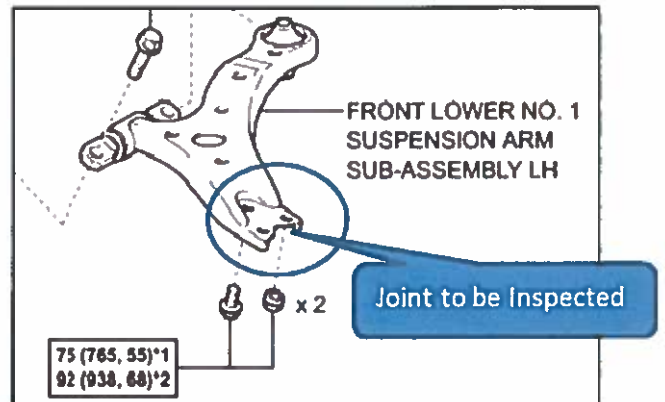
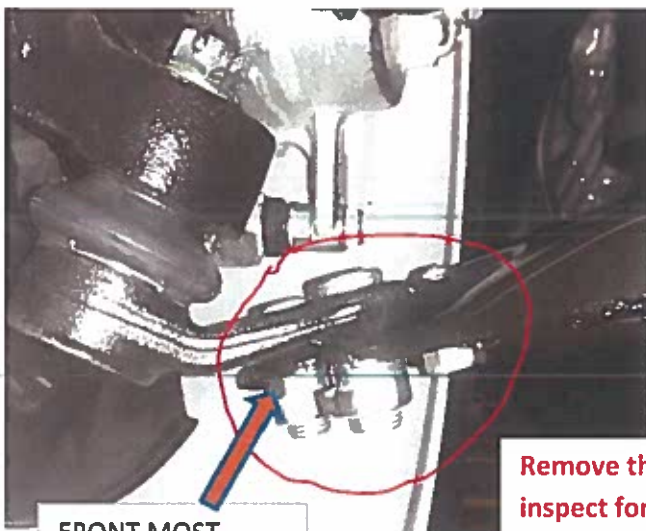
Remove the forward nut only and inspect for any missing material on the control arm

NG MISSING MATERIAL

If any vehicles are found with the mis-stamp condition, replace the control arm and perform an alignment. TMS will also provide warranty reimbursement details.

1. Raise the vehicle on a lift
2. Inspect the left front lower control arm where the ball joint attaches to the lower arm.
3. Remove the **forward nut only** and inspect the lower arm for missing material as shown in picture.
4. If no material is missing, re-install the nut and torque to spec.
5. If material is missing replace the lower control arm and preform an alignment
6. We want to recovery any replaced control arms for additional investigation.
7. Once completed, report the results (Good or Bad) by VIN # to the Region.

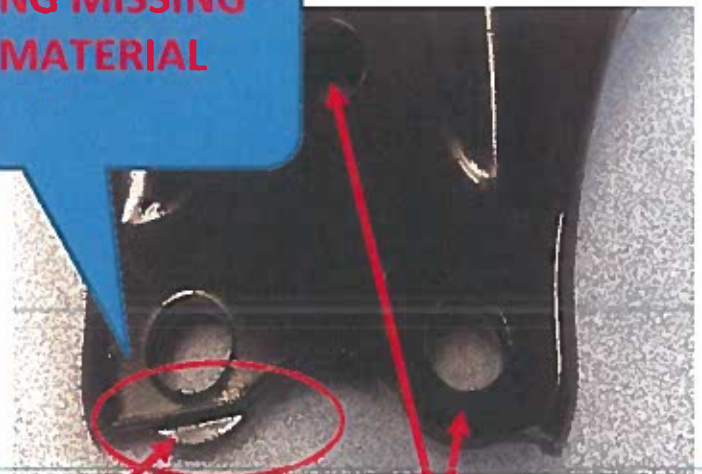
DO NOT remove the other nut and bolt holding the ball joint to the lower control arm.
