Driver Seat - LH Rear Bolt Cover Deformation

Service Category Vehicle Interior

Section Seat

YEAR(S)	MODEL(S)	ADDITIONAL INFORMATION
2014	Tundra

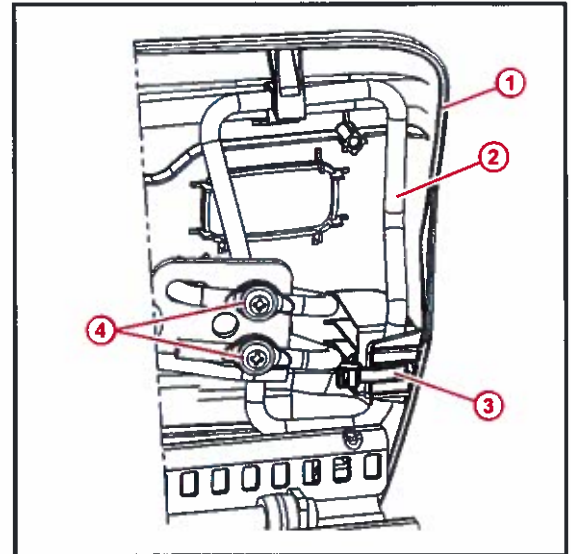
Figure 2.

1	Side Shield
2	Wire
3	Zip Tie
4	Wire Attachment Screws

A. Remove the side shield (zip tie may be cut).

B. Remove the Front Seat Cushion Shield Wire LH from the frame by removing the 2 wire attachment screws.

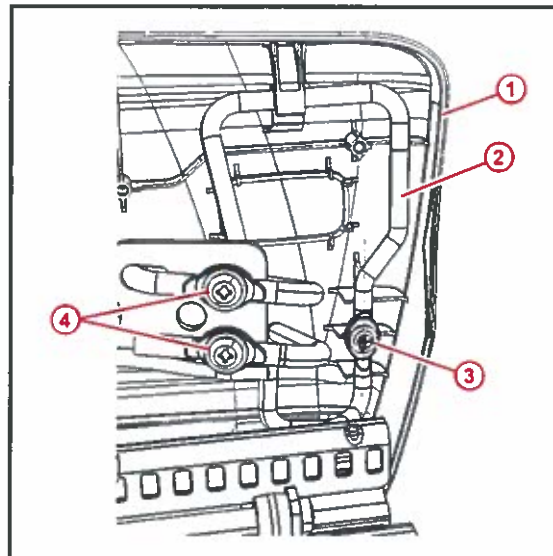
Figure 3.

1	NEW Side Shield
2	NEW Wire
3	NEW Screw (P/N 90080-16089)
4	Wire Attachment Screws

- C. Attach the NEW Front Seat Cushion Shield Wire LH.

- D. Attach the NEW side shield screw.

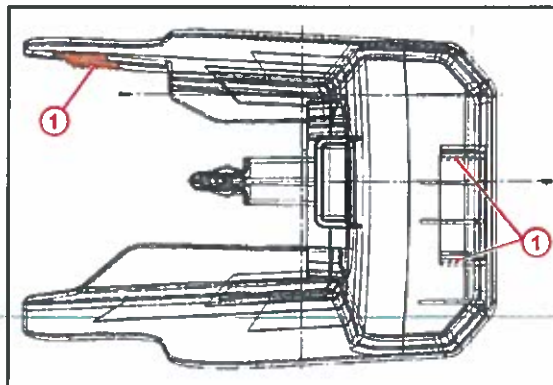
Figure 4.

The rib on the new cover is longer than the original part by 15 mm.

1	Outer Rear Seat Track Bracket Cover LH
---	--

3. Replace the original Outer Rear Seat Track Bracket Cover LH with the NEW Outer Rear Seat Track Bracket Cover LH.
