MODEL
2012-13MY
Optima (QF)

NUMBER
104

TECHNICAL SERVICE BULLETIN

SUBJECT: DRIVER'S SIDE SEAT CUSHION COVER DETACHING

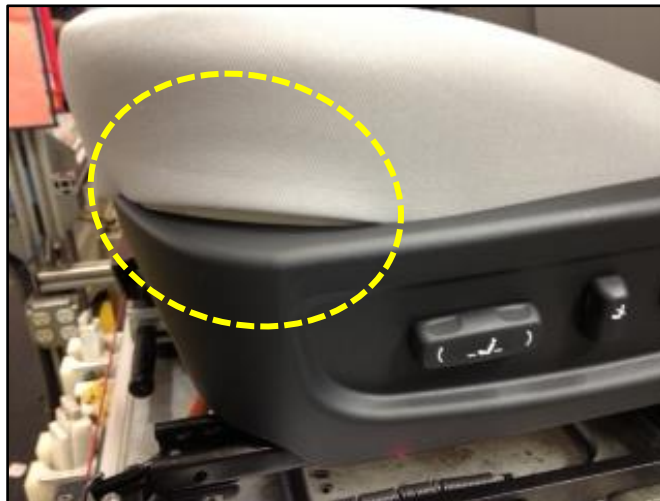
This bulletin provides information about some 2012~2013MY Optima (QF) models, produced from August 9, 2011 through April 11, 2013, which may experience a loose or disengaged driver's side seat outer trim cover. Follow the procedure outlined in this TSB to correct the concern.

Seat Cover Detached
