GROUP <b>Body</b>	MODEL <b>2006-2014MY Sedona (VQ)</b>
	NUMBER <b>PS306</b>	DATE <b>June 2014</b>

SUBJECT: SECOND ROW SEAT RELEASE MECHANISM INOPERATIVE

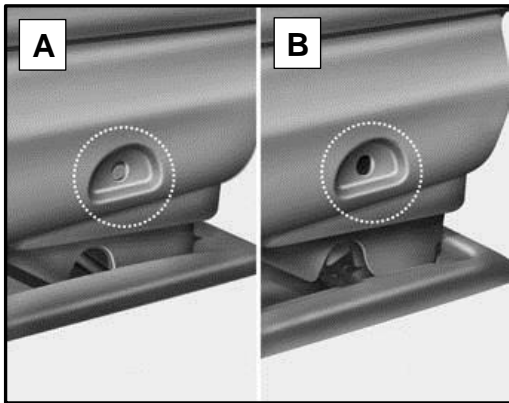
- Latch lock indicator shows a green circle on both sides of the seat base (A). If the green circle is not visible (B), make sure the seat is properly latched.

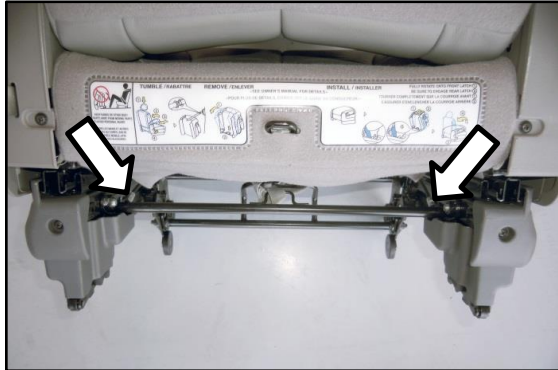
1. Move the seat to the full forward position and locate the seat release cables on the left and right side of the seat track.

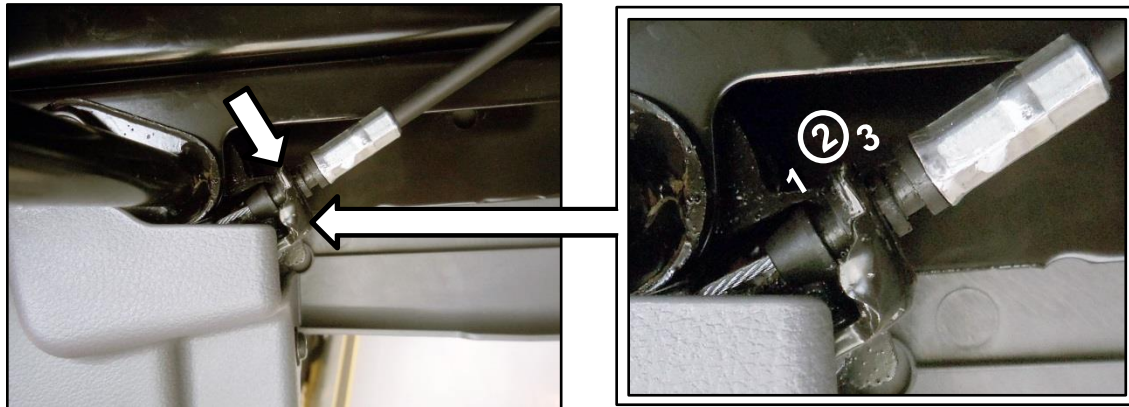
2. Check the current position for the seat release cable adjuster. The default setting from the factory is in slot two (2).

3. If more tension is required to operate the release mechanism, remove the cable adjuster from the default slot and place it in slot one (1).
4. If there is excess cable tension in the mechanism, remove the cable adjuster from the default slot and place it in slot three (3).
5. Operate the seat release handle to make sure the seat will tumble forward.
6. Repeat the steps above on the opposite side second row seat, if necessary.
