TECH TIMES

The Professional Publication for Kia Dealership Technicians & Service Staff

Volume 17, Issue 3

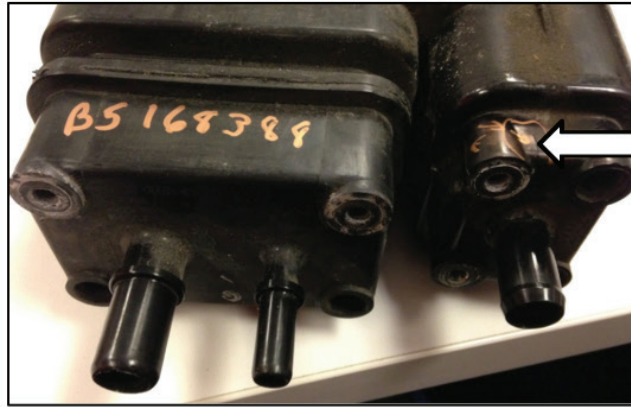
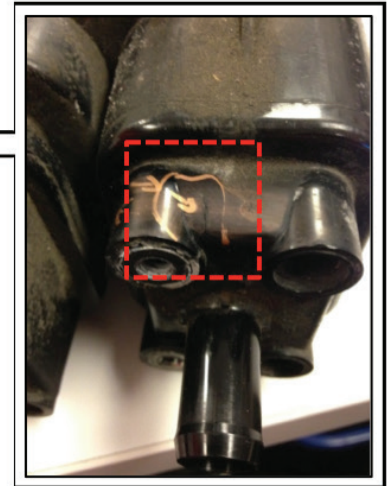
When addressing a concern related to a DTC P0456 (Evaporative Emissions System – Small Leak Detected) on 2011-2014 Optimas, and inspection of the vapor lines, connections and fuel cap reveal no abnormalities, closely inspect the mounting holes of the charcoal canister for visible cracks (refer to the images to the right). If cracking is found, replace the charcoal canister per the applicable procedure on KGIS. If no cracking is found, please proceed with normal evaporative system diagnostics.

Please refer to Pitstop PS 322

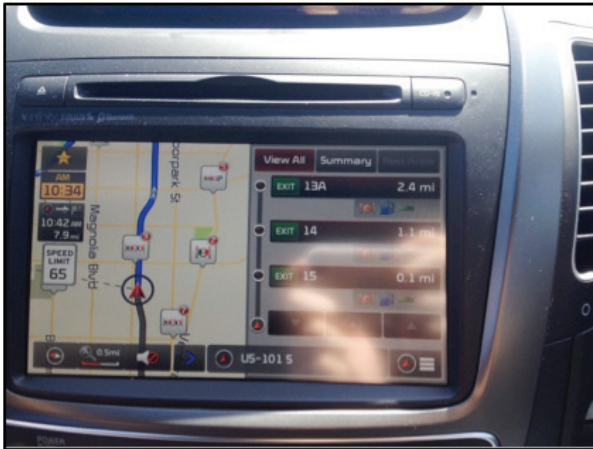
Sirius® traffic is not being displayed

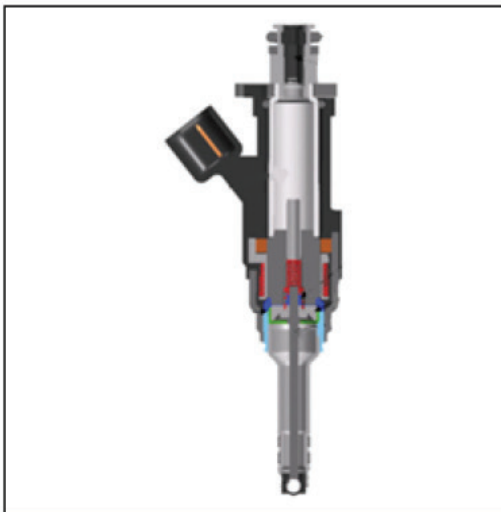
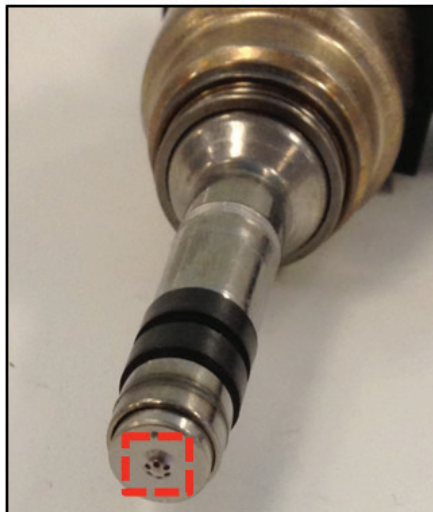
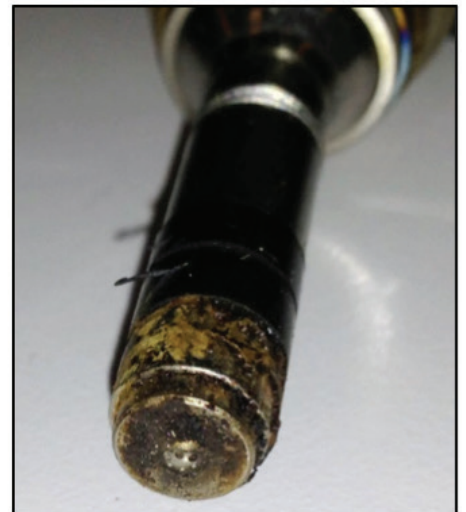
A design feature of vehicles equipped with a Gasoline Direct Injection (GDI) system is the placement of each fuel injector directly into the engine cylinder head assembly. Therefore, it is completely normal for the combustion process to create deposits on the injector spray tip surfaces. Although spray tip deposits may appear to be heavy enough to affect injector performance, there is actually no change in the fuel delivery or spray pattern. GDI injectors operate at high pressure and deliver fuel through small spray orifices near the center of the injector tip, at a high velocity. As a result, combustion deposits that form near the injector spray orifices are washed away as fuel is delivered. In addition, the injector ball and seat are engineered to reduce any potential effects of carbon coking.

The internals of the Injector are designed to minimize the formation of deposits

New injector showing location of Spray Orifices

Normal injector appearance while in service

NOTE: Ultra-sonic or mechanical cleaning of GDI fuel injectors should never be done in an attempt to improve vehicle drivability or injector performance. Attempting to remove spray tip deposits through mechanical means, such as wire brush cleaning or scraping, will damage the spray orifices and degrade injector performance.

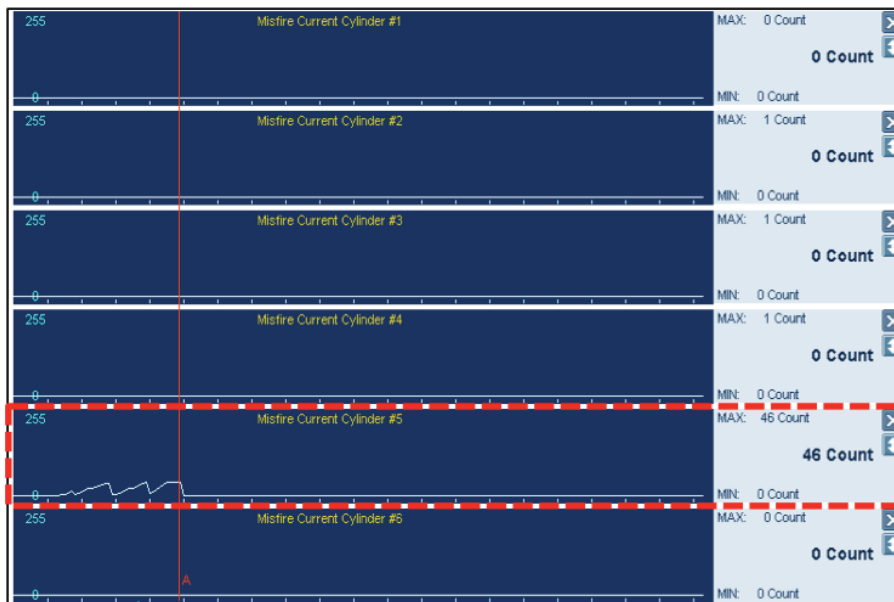
When addressing a customer complaint of rough idle on a Sorento or Cadenza, which occurs only on the first start of the day and lasts for, approximately, 30-45 seconds, check for the possibility of poor injector performance on a particular cylinder. This concern may feel like a misfire, however, it is not an emissions or catalyst damaging misfire and it does not typically trigger any DTC(s). To correct this condition, use GDS to monitor for Current Misfire Counts on all 6 cylinders during the first cold start in the morning, to help determine which cylinder is responsible for the rough idle condition. Replace only the injector for the indicated cylinder. To verify the repair, recheck again after an overnight cold soak to make sure the rough idle condition is no longer present.

The example below shows a rough idle condition on cold start due to the Injector in Cylinder #5.

Please refer to Pitstop PS 320

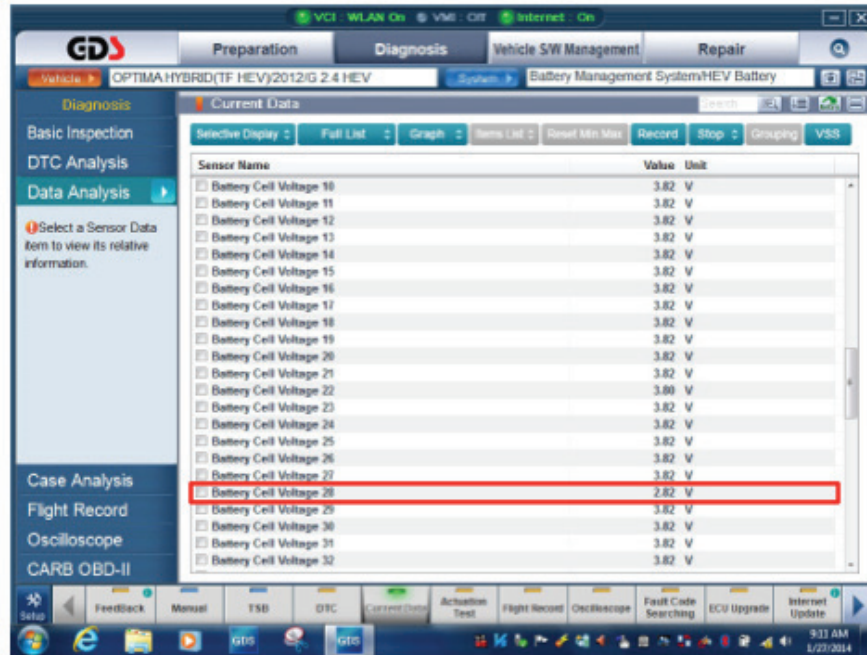
When addressing a customer complaint related to a battery warning lamp illuminated in the dash and drivability issues on Optima Hybrid, access GDS to check for any active DTC(s). Also, review the **BMS > Current Data** to inspect for one or more HEV battery cells showing one (1) volt, or more, lower than the than rest of the cells (see below). Duplicating this condition may not be possible when viewing in Ready Mode. If so, test drive the vehicle with a flight recorder to capture the event in city driving conditions. Send all supporting information to Techline for documentation of condition and further diagnosis.

Please refer to Pitstop PS 292
