GROUP Body	MODEL 2011-12MY Sorento (XMa)
	NUMBER 090 (Rev 1, 09/11/2014)	DATE March 2012
TECHNICAL SERVICE BULLETIN		
SUBJECT: DRIVER'S SIDE POWER SEAT TRIM COVER REPLACEMENT AND WASHER RELOCATION

This bulletin provides information about some 2011~12MY Sorento models produced before November 1, 2011 that may experience a loose or disengaged driver's side seat outer trim cover from the mounting bracket assembly. Follow the procedure outlined in this TSB to replace the Driver's Side Seat Trim Cover and relocate a front bracket shimming washer from the bottom hole to the top, to slightly angle the trim mounting bracket away from the seat cushion. After performing the TSB, if there are repeat repairs related to this trim cover replacement, please contact technical assistance.

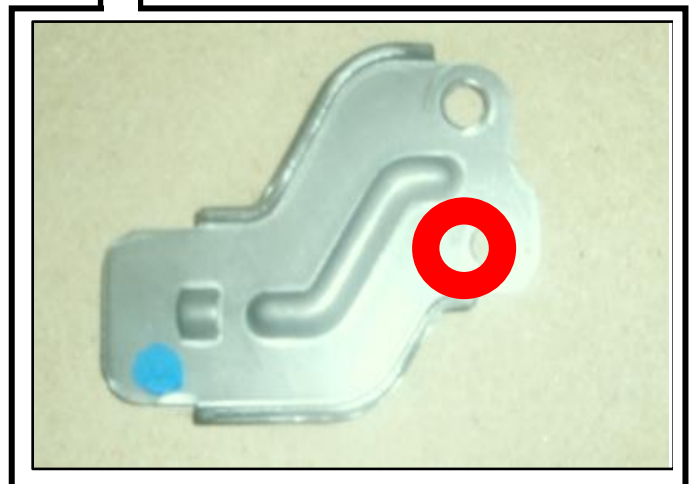
Check for the presence of washer between bracket and frame, if it's located on lower screw continue to step 9. Otherwise, skip to step 13.

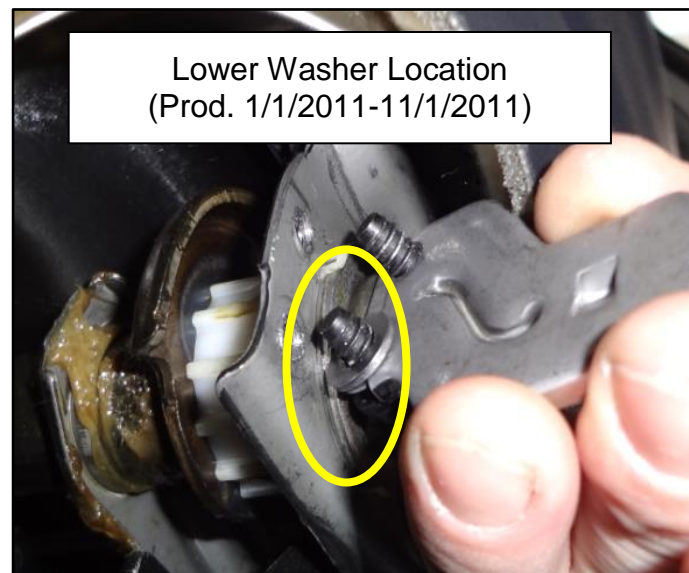
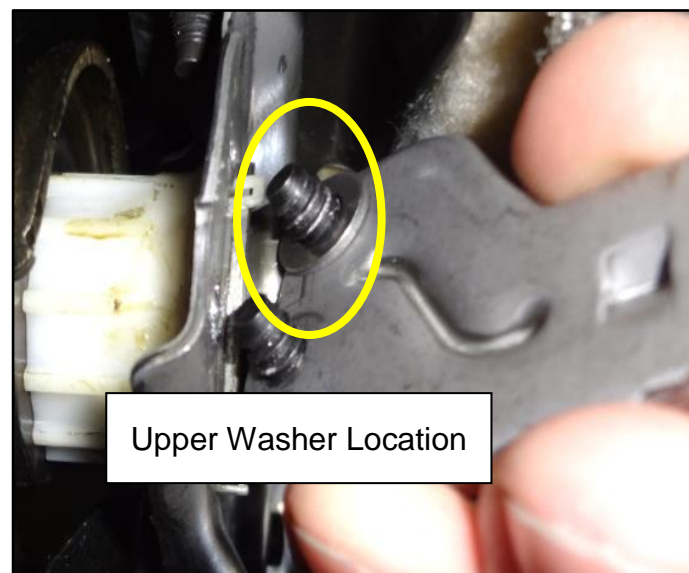
10. Locate the washer on the back side of the bracket, around the lower mounting screw. Check position.

- Vehicles produced from January 1, 2011 to November 1, 2011 will have washer located on Lower screw.
- On vehicles produced before January 1, 2011 and after November 1, 2011 washer will already be in correct position no re-location is needed.

11. If washer is located on bottom remove the washer and install onto the top screw. If washer is already located on top no change needed.

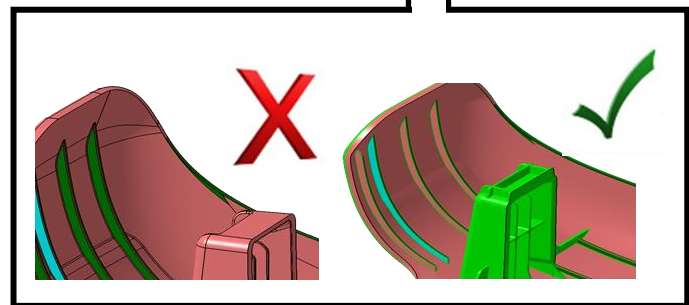
Check to make sure bracket has improved rib design, verify presence of A-clip
