MODEL
Sorento (XMa)
2011-2013MY

NUMBER
093 (REV 3, 10/31/2014)

TECHNICAL SERVICE BULLETIN

SUBJECT: SECOND ROW SEAT INOPERATIVE OR DIFFICULT TO RELEASE

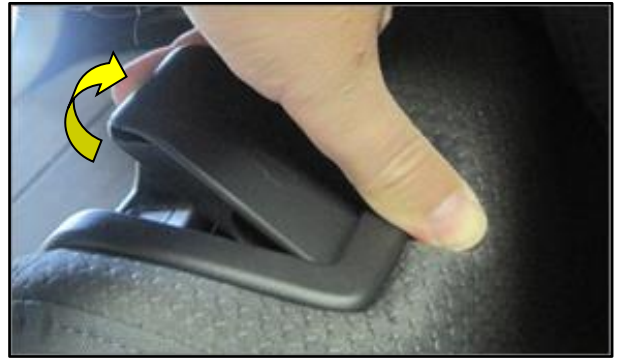
Verify excessive effort required to operate handle.
