GROUP Engine	MODEL 2012-2013MY Rio 1.6L GDI (UB)
	NUMBER 131 (REV 1, 11/06/2014)	DATE April 2013
<b>TECHNICAL SERVICE BULLETIN</b>		
SUBJECT: ECM UPGRADE – KNOCK IMPROVEMENT

## ECM UPGRADE – KNOCK IMPROVEMENT

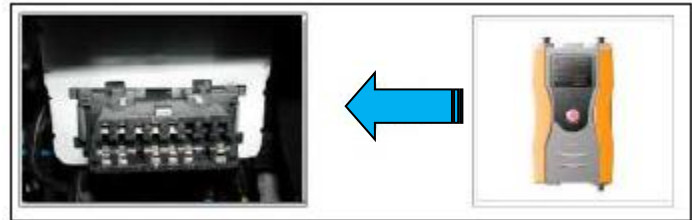
- Connect the Main 16-pin DLC cable (GHDM – 241000) to the OBD-II connector, located under the driver's side of the instrument panel.

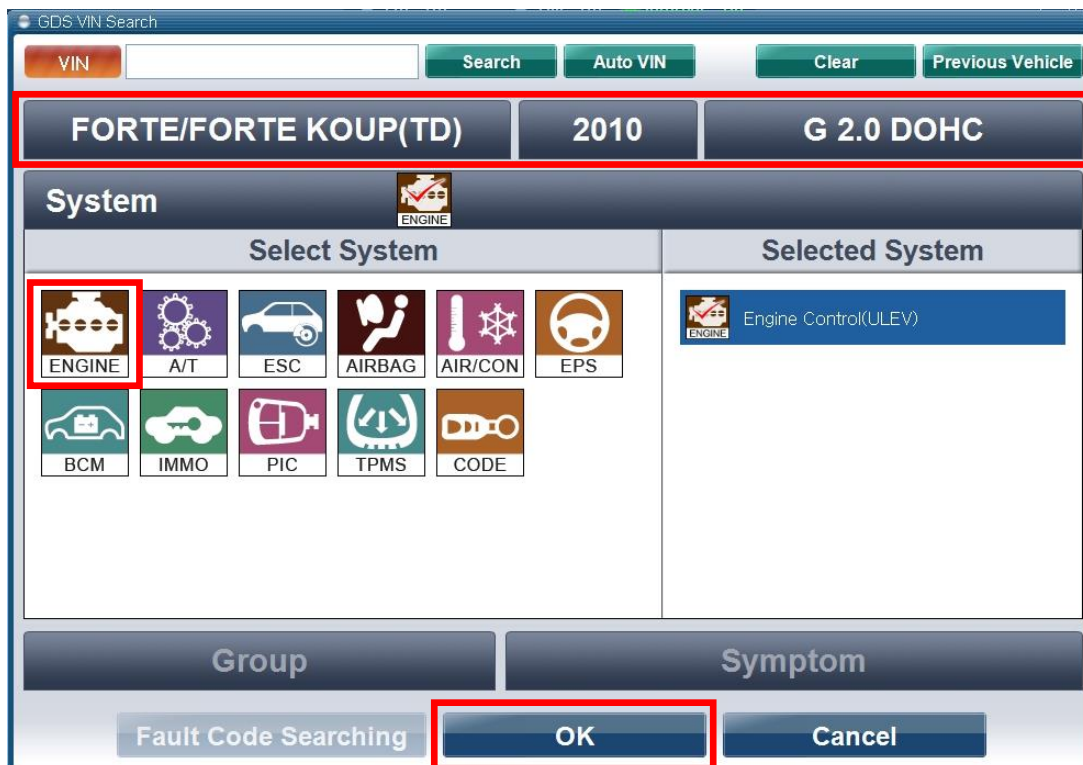
- With the ignition key ON, turn ON the VCI and GDS tool. Access the GDS vehicle identification number (VIN) screen and configure the vehicle using the VIN AUTO DETECT Function.
- Select ENGINE system and click OK.
