| REFERENCE: | Nova Bus Manuals |
| RS N°: | MQR 7621-1030 |

| SUBJECT: | Right wall structure with 1:6 ramp |
| JUSTIFICATION: | Vertical beam might crack above front door, second post capping. |

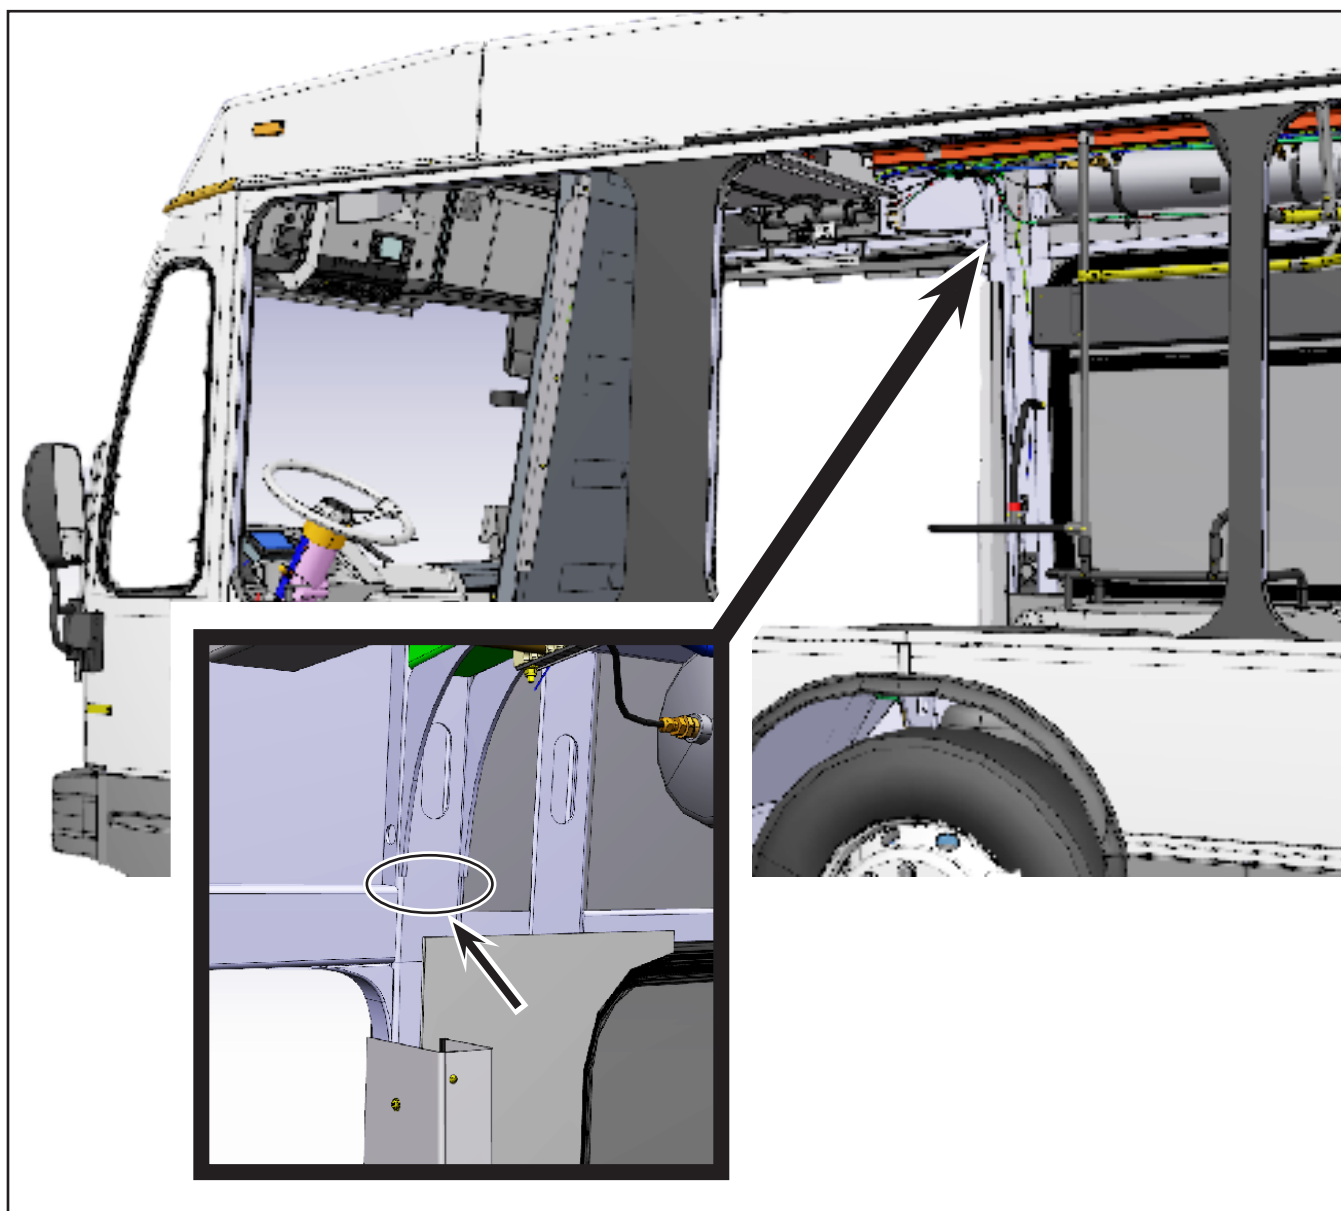
Figure 1 - Possible Crack Location

- 1.17. Inspect the area shown in Figure 1. If a crack is found, make 1/8 in. stop holes at one or both ends if possible.
