# TECHNICAL INSTRUCTIONS

## X4 7300 & 7500 SAS HARNESS REROUTE

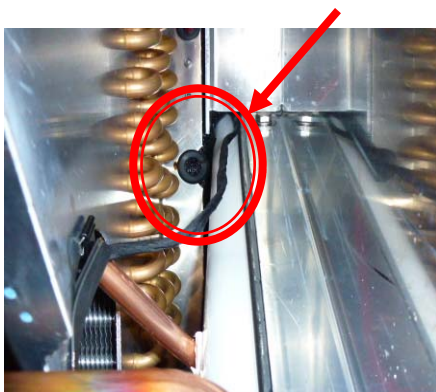
It has been determined that Carrier Transicold X4 units, models 7300 and 7500, in the serial number range PAX91377926 through PAX91378858 require the supply air sensor (SAS) harness to be rerouted. Failure to reroute this harness could lead to chaffing of the wiring harness, potentially causing failure of the SAS. Failure of the SAS could affect the unit temperature control.

**Missed routing wire through grommet**

1. Ensure the unit will not start automatically by disabling any two way communication and placing the units On/Off switch in the off position. Disconnect the Negative battery cable.
2. Remove Evaporator panel
3. Remove the Prestite tape securing the SAS harness where it is routed through the evaporator coil.
4. Reroute the SAS harness through the grommet (see pictures below).
5. Re-secure the Prestite tape to prevent any movement of the SAS harness.
6. Reinstall evaporator panel.
7. Reconnect the negative battery cable.
8. Turn unit on, run and check for proper operation.

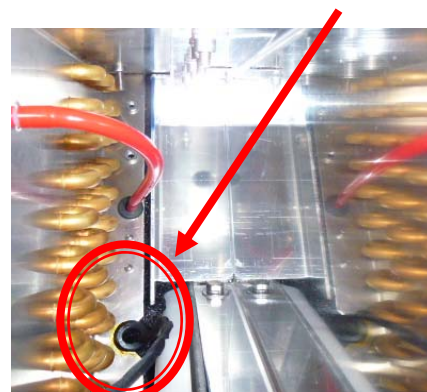
**Proper routing of SAS Harness**
