SER13-015 Rev A  
07/15/2014

## SUBJECT: Direct Drive Suction Line Fitting

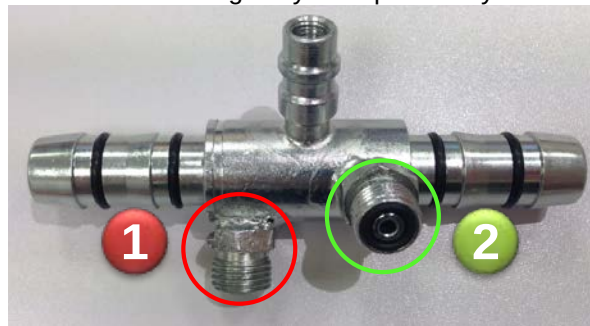
It has come to our attention that the multi-port suction line fitting that was recently introduced on the direct drive product line, may be delivered with one or both of the oil return fittings blocked with brazing alloy. The potentially affected ports are shown as #1 and/or #2 below.

It is highly recommended that prior to installation this fitting be visually checked for no obstructions that could impact compressor reliability. This inspection is to ensure lubricating oil can return from the oil separator to the compressor crankcase. Further to this, if a unit experiences a road compressor failure it is advisable to check for this condition.

If an obstructed port is found, the blockage can be removed by drilling out the braze material with a .125" or 3.17mm drill bit. If the fitting is installed in a system it is necessary to remove the fitting from the refrigeration system and drill out the material at a workbench. This is to prevent drill material from entering the refrigeration system.

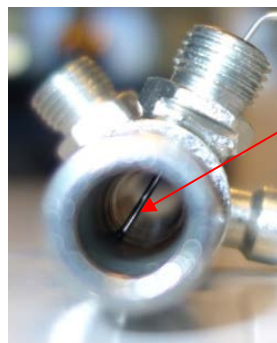
Example of  
"unobstructed"  
port.

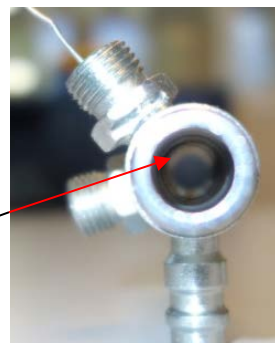
Example of  
"obstructed"  
port.
