## INSTRUCTION TO SERVICE

**ITS: 5910**

| <b>SUBJECT:</b> | Part A: Trim Rear crown panel and bracket to prevent contact on HV cables<br>Part B: Inspect BAE accessory cables and cut back cable insulation to $\frac{3}{4}$ " if required |

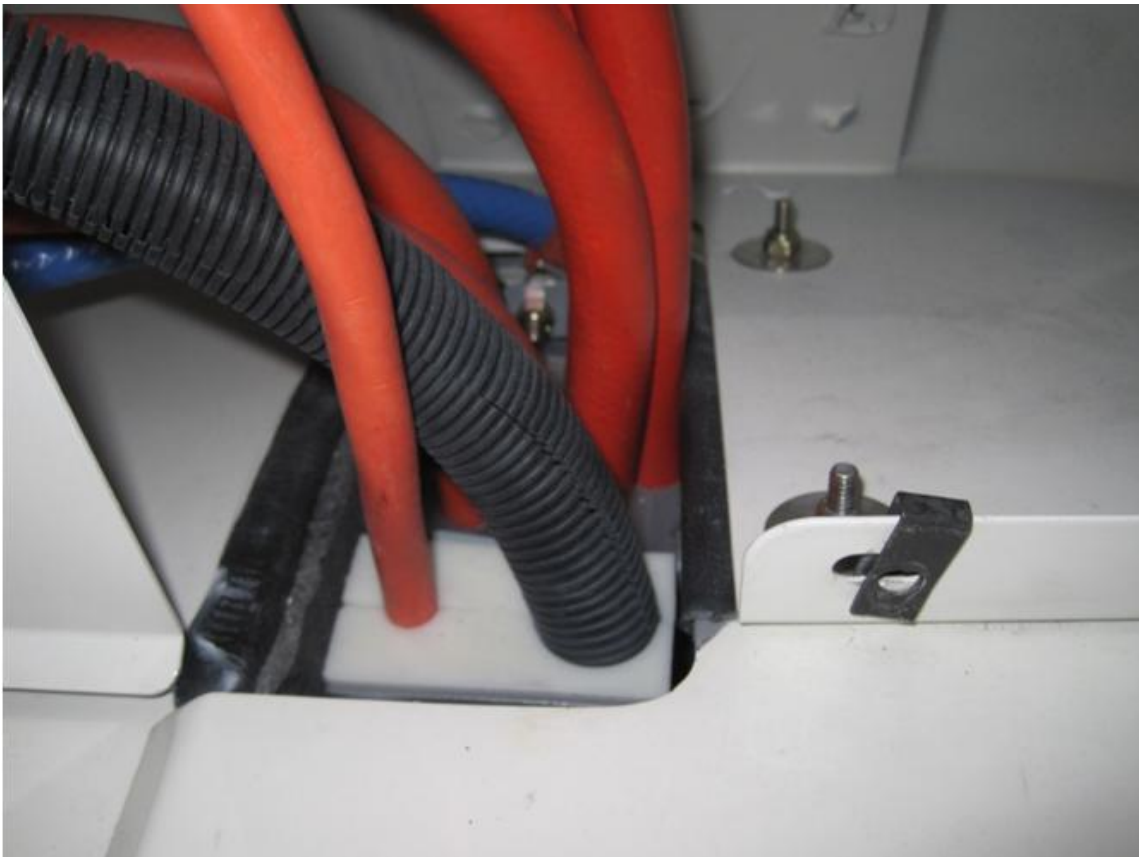
**Figure 1: Typical BAE HV cables installation**

1. Turn the main battery disconnect switch to the “OFF” position.
2. Inspect the BAE Hybrid HV cables at the curbside rear corner of the bus and check if the cables are chafing on the roof crown panel and bracket as shown in Figure 1.
