DART CNG Front Cap rubber

Issue: Rubber seal coming loose from front cap

Engineering Documentation: ECN N13-34151

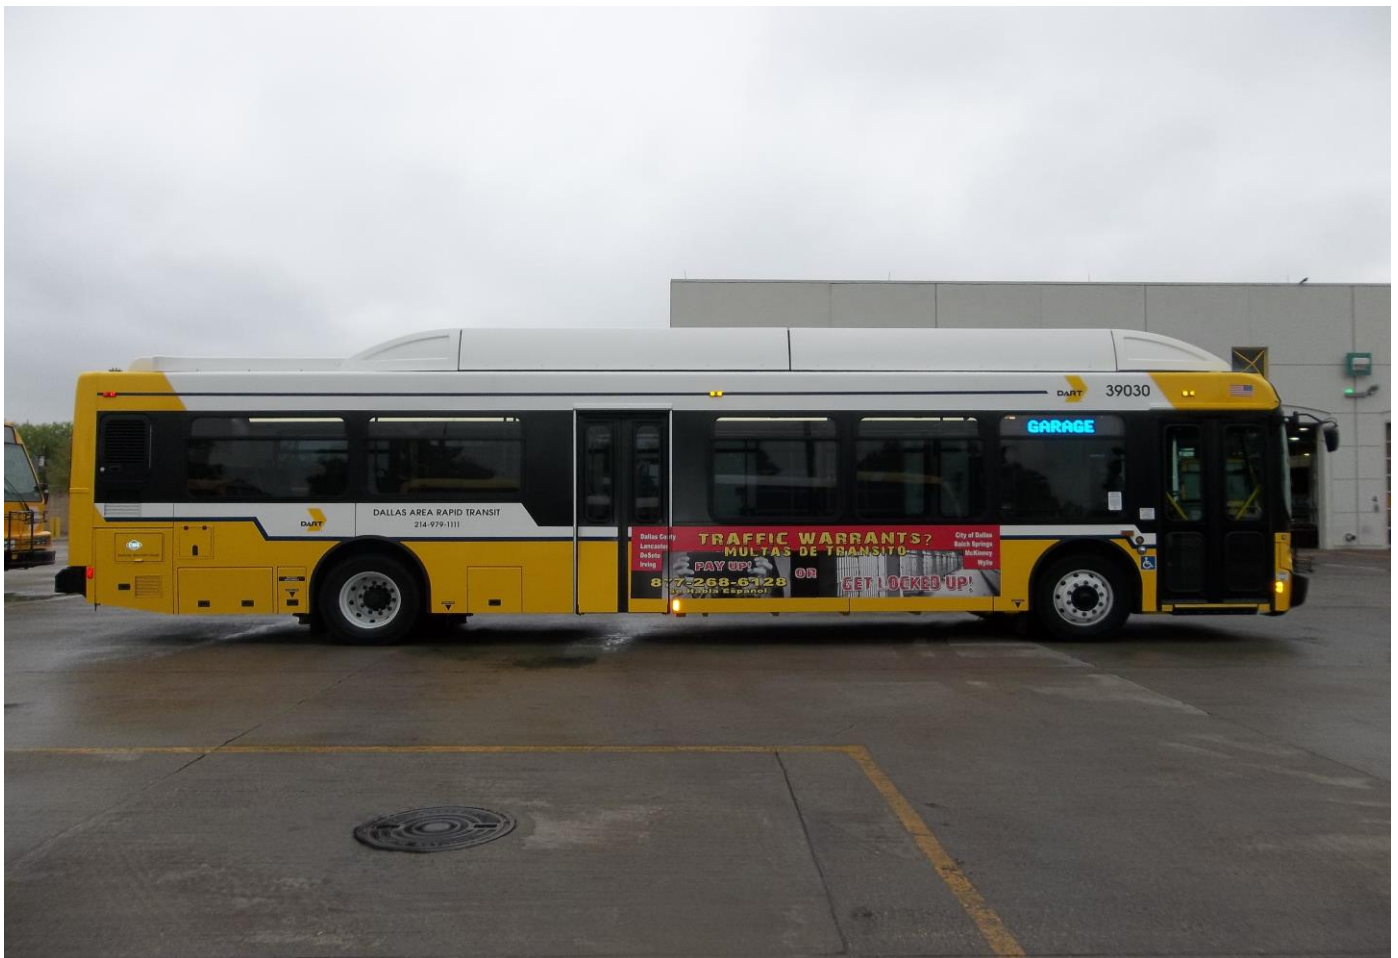
Reason/ cause: Metal in bulb seal is not encased with rubber

Solution: Replace with different rubber seal

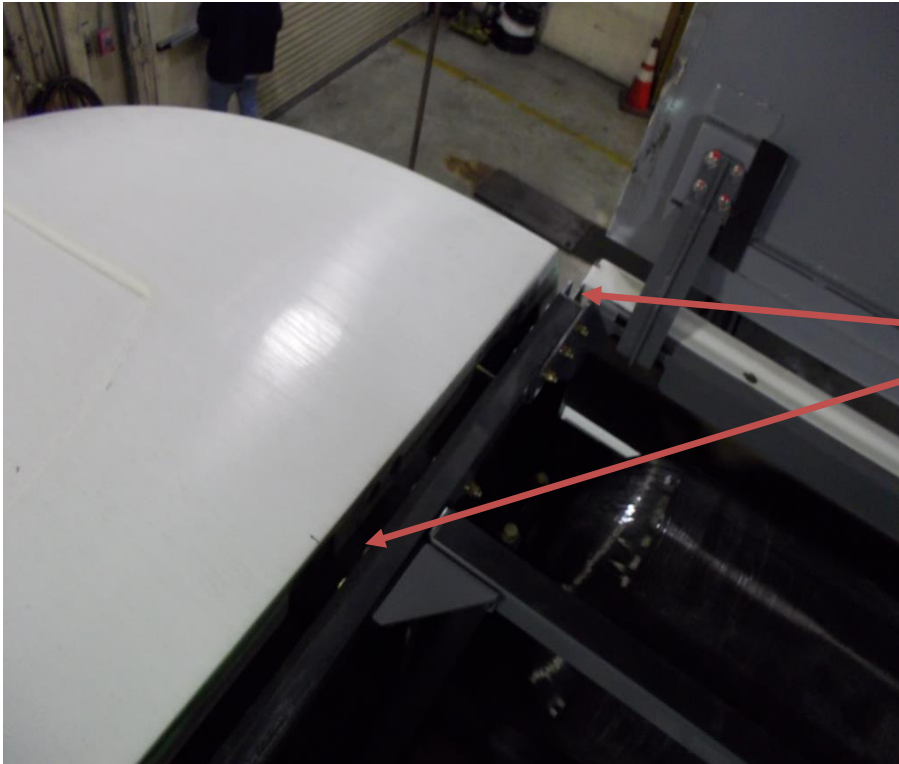
There are 14 bolts along the edge of the cap

1. Park the bus and apply the parking brake.
2. Turn off main battery disconnect switch(es)
3. On the roof you must open the front CNG doors. Then the CNG front cap must be moved. There are 14 1/4x20 bolts that must be removed.

4. Slide the cap forward then raise it up put it on a board remove the old rubber and install the new.
5. Set it back on the top of the bus slide it cap back making sure retainers align up.

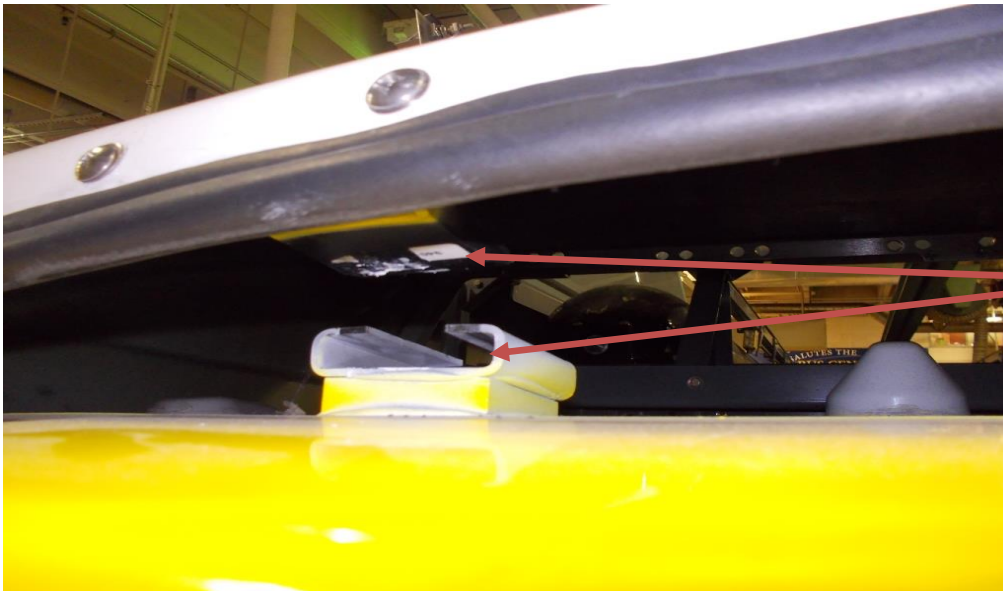
Make sure the
retainer clips
go inside
bracket

6. **Put all the bolts back.**
7. Check for completeness of work.
8. Remove all tools from working area.
9. Turn the main battery disconnect switch(es) on.
