LA 45 COMPO: Headlight Mount Rework

Property name and top bus number: LA 45CLFW 218000, 269000

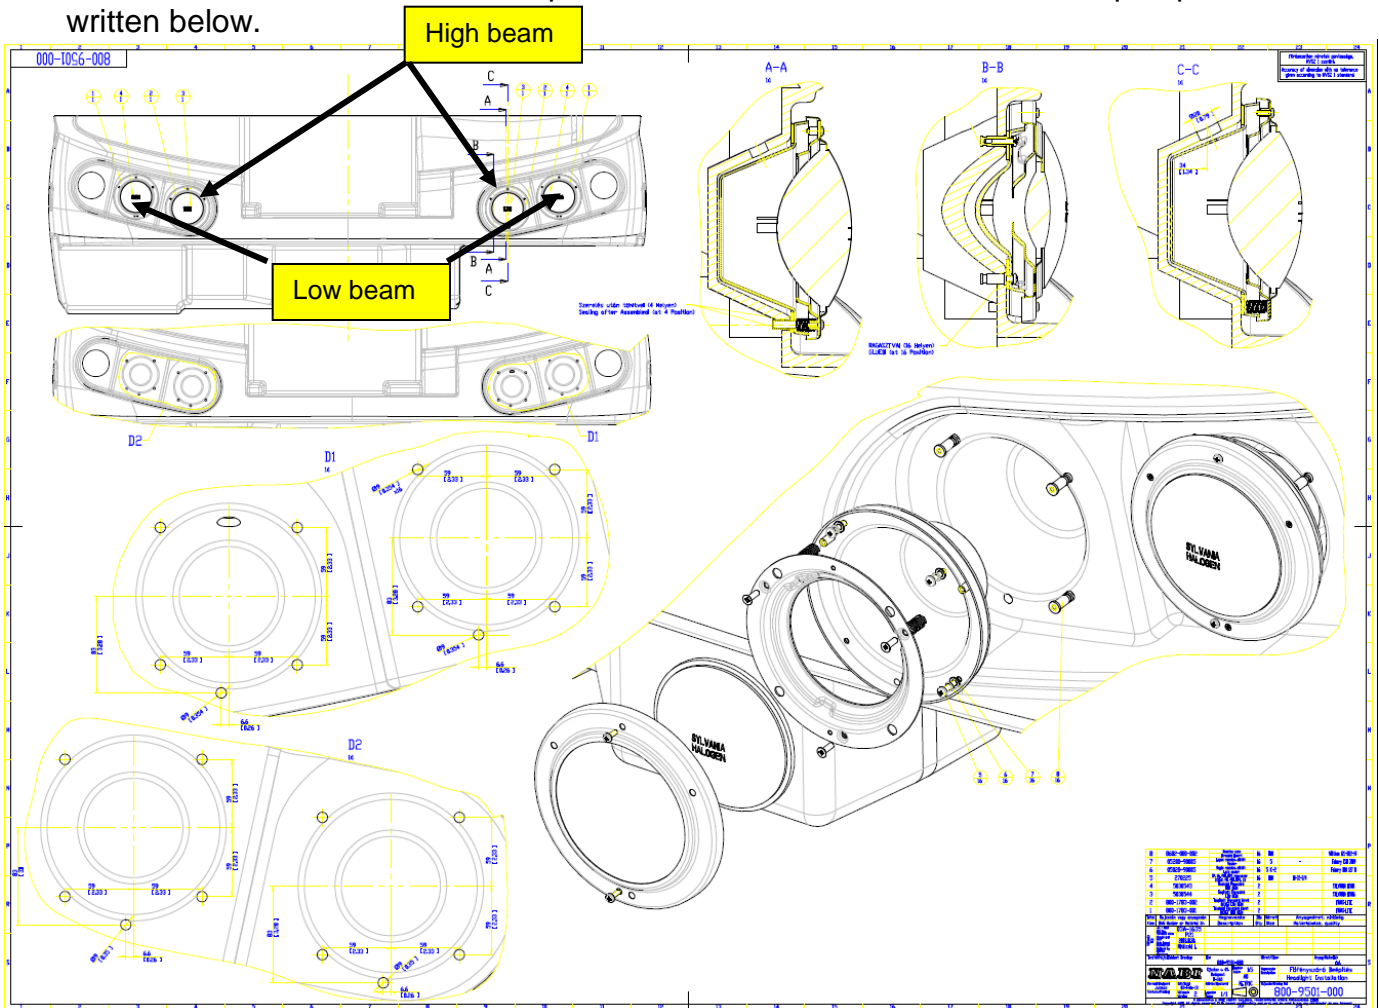
1. Park the bus on a flat surface and apply the parking brake.
2. Inspect buses and check if the low and high beam bulbs are installed per the drawings below. If the location or the number of required bulbs are mixed then follow the repair procedure written below.
