FRONT BUMPER WASHER INSPECTION / REPLACEMENT

Property and Top Bus Number: NJT: 305000

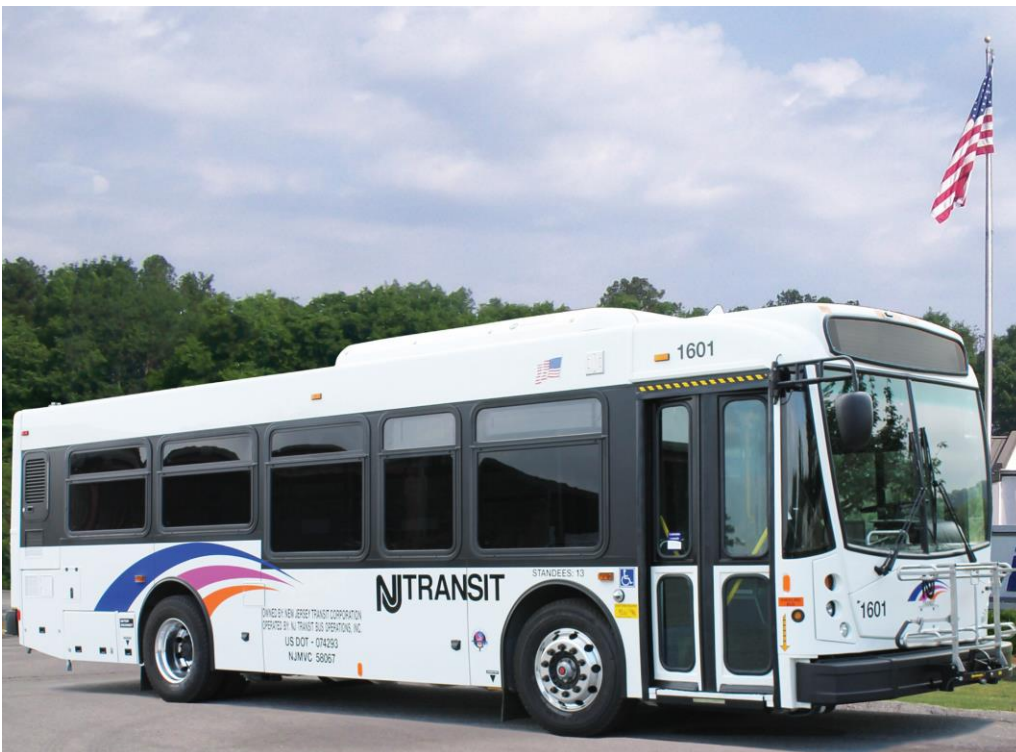
Issue: Rusting Flat Washers on Front Bumper Mount

Reason/ cause: Washer was not Plated as Specified

Solution: Inspect and Replace Washers if Corroded / Improperly Plated

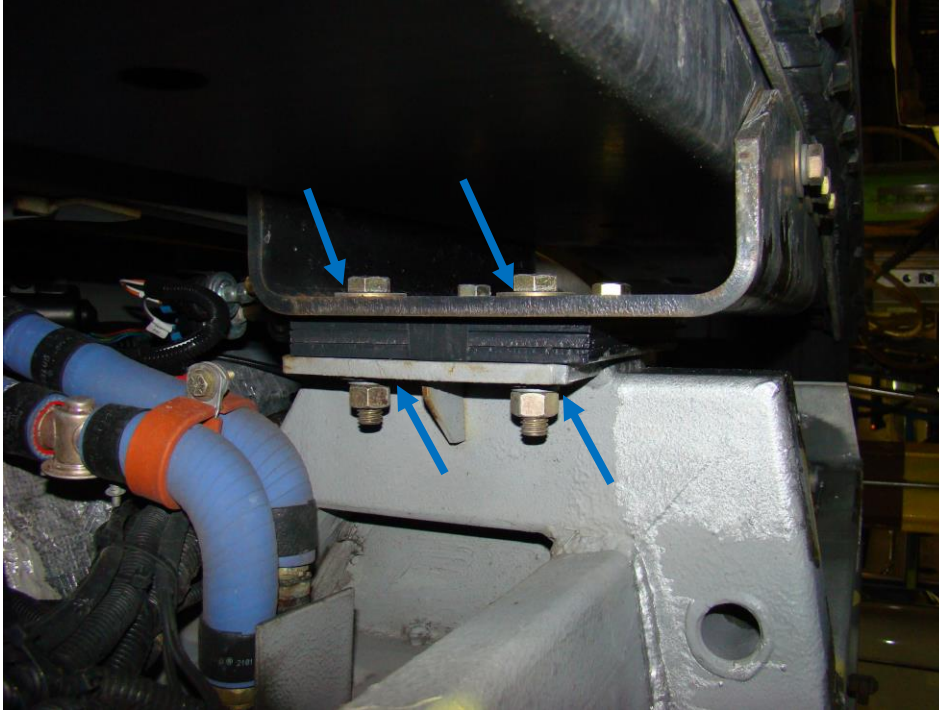
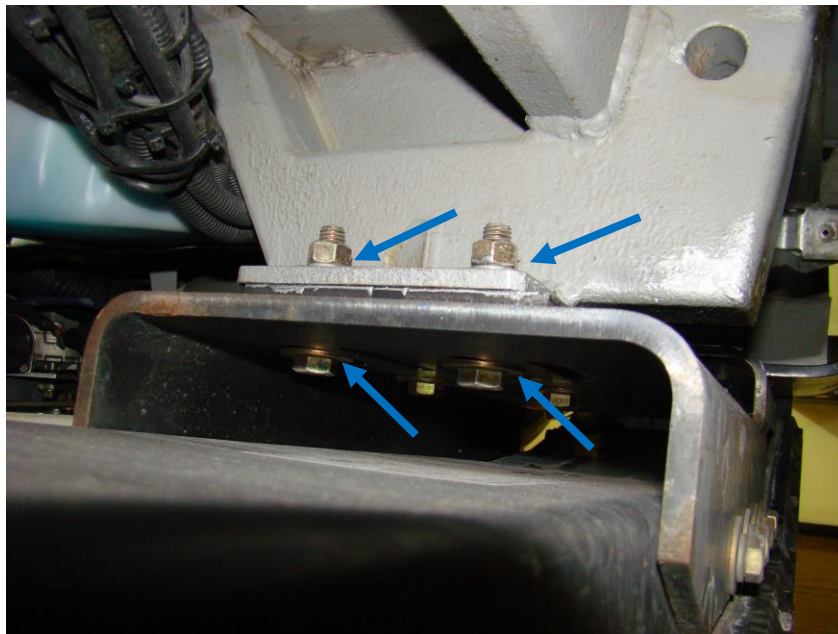
1. Park the bus and apply the parking brake.
2. Turn off main battery disconnect switch(es).
3. Inspect washers for rust/corrosion (see below). Replace if necessary.
