# Corrosion Inspection Behind the Lower Cove Panels

**Property and Top Bus Number:** NJT 305000

**Issue:** Corrosion inspection behind the lower cove panels

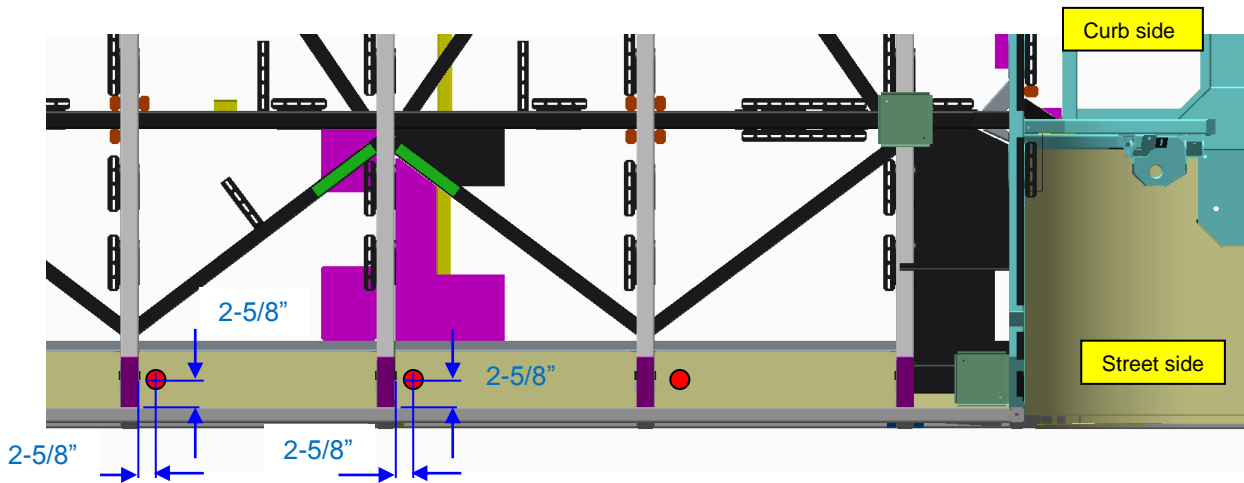
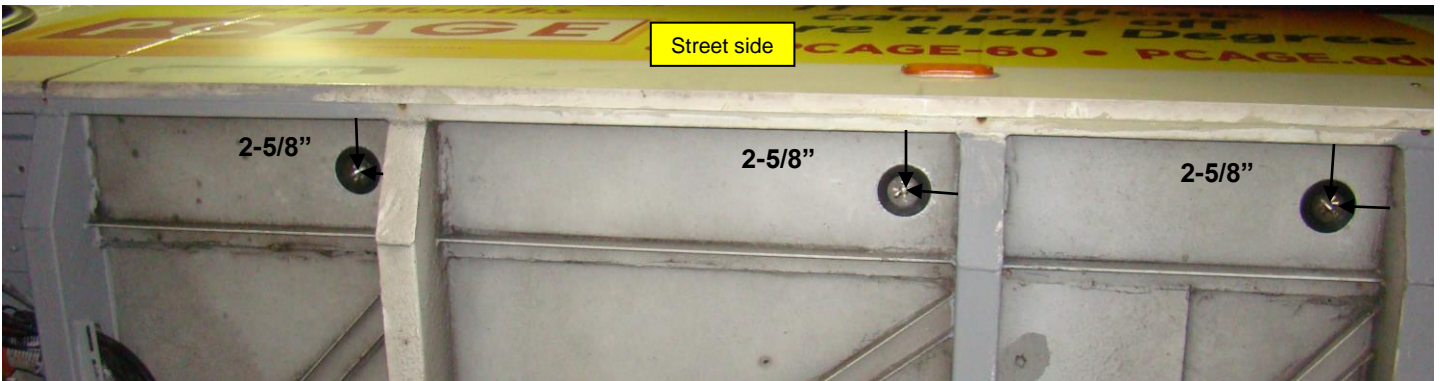
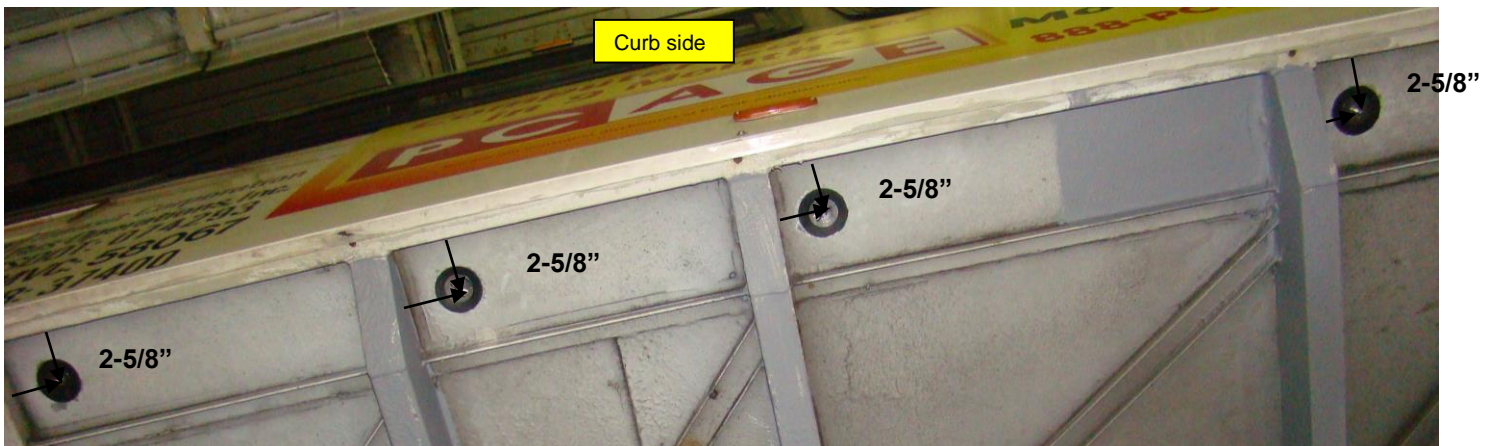
1. Park the bus on a flat surface and apply the parking brake.
2. Turn off main battery disconnect switch(es).
3. Mark the dust panels as pictures show below. On the underside of the bus below the sidewalls, place 3 marks for drilling on street side and 4 marks on curb side.

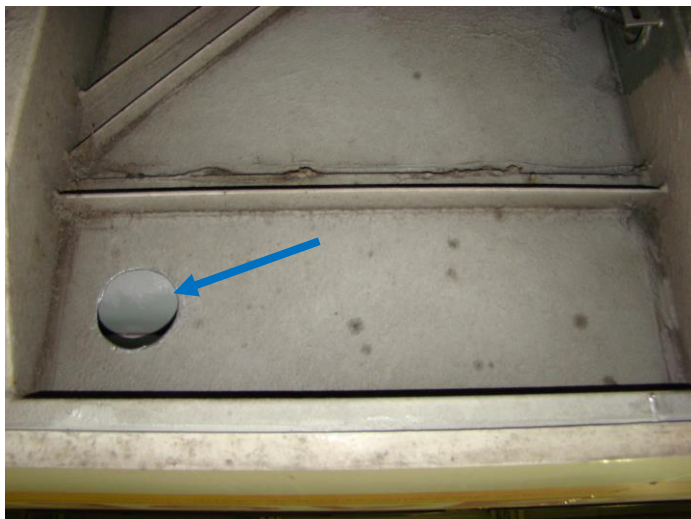
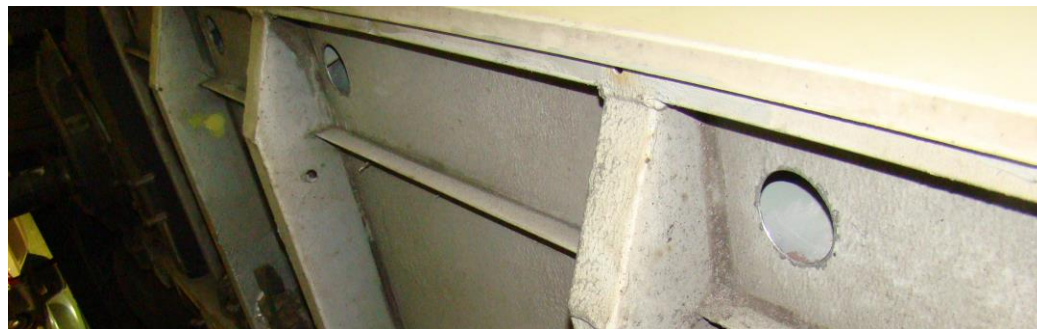
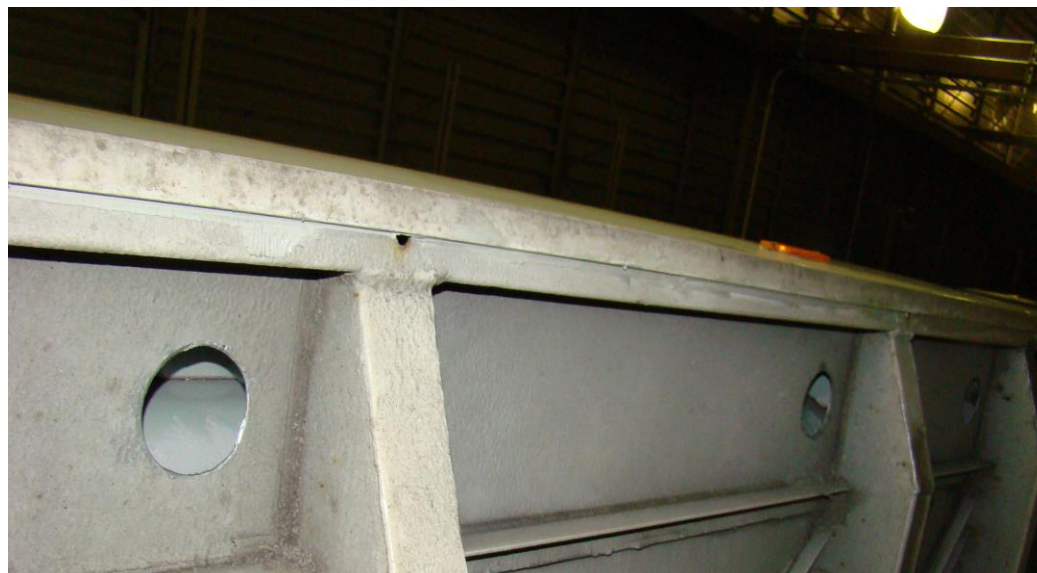
4. Drill a 1/4" pilot hole at the marks.
5. With a hole saw, cut 2-3/8" diameter size hole at the 1/4" pilot holes.

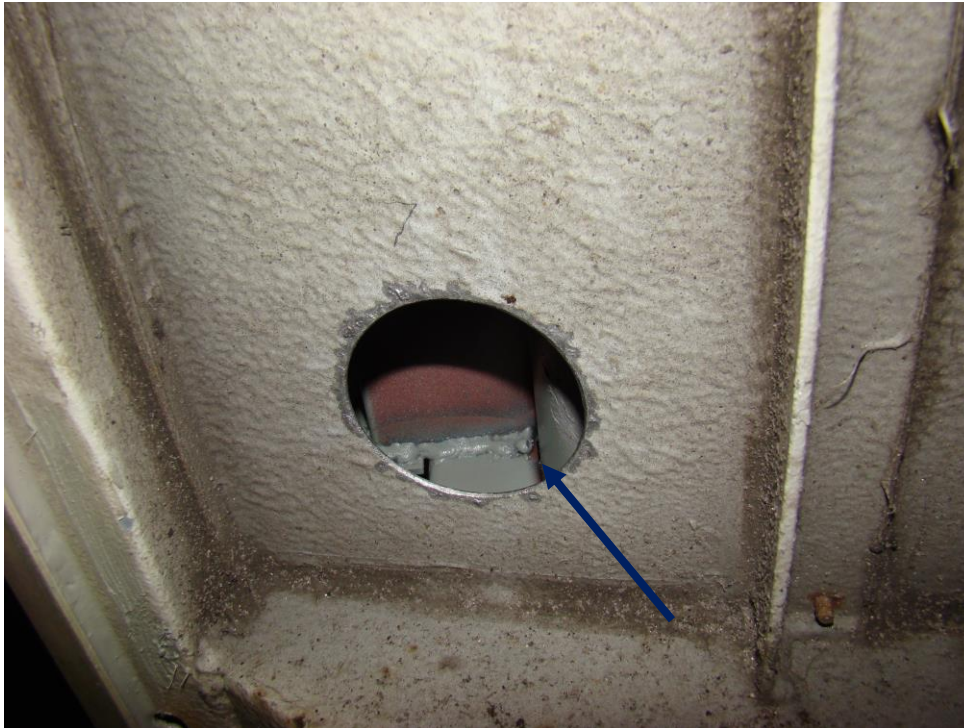
6. De-burr holes by using the de-burr tool.
7. Inspect structure behind the dust panel. Use bore scope or mirror as required. Record findings on bus work order.

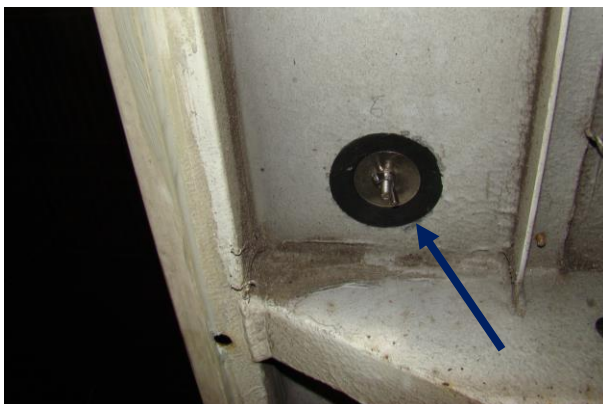
8. Degrease edge of the hole with acetone.
9. Apply POR-15 paint to the edges of the previously drilled holes. Follow instructions written on the paint can.
10. Install rubber plugs in the holes.
