**ITS: 5666**

| <b>SECTION:</b> | 526 Seating and Stanchions |
| <b>SUBJECT:</b> | Remove lower barrier panels at the exit door and replace. |

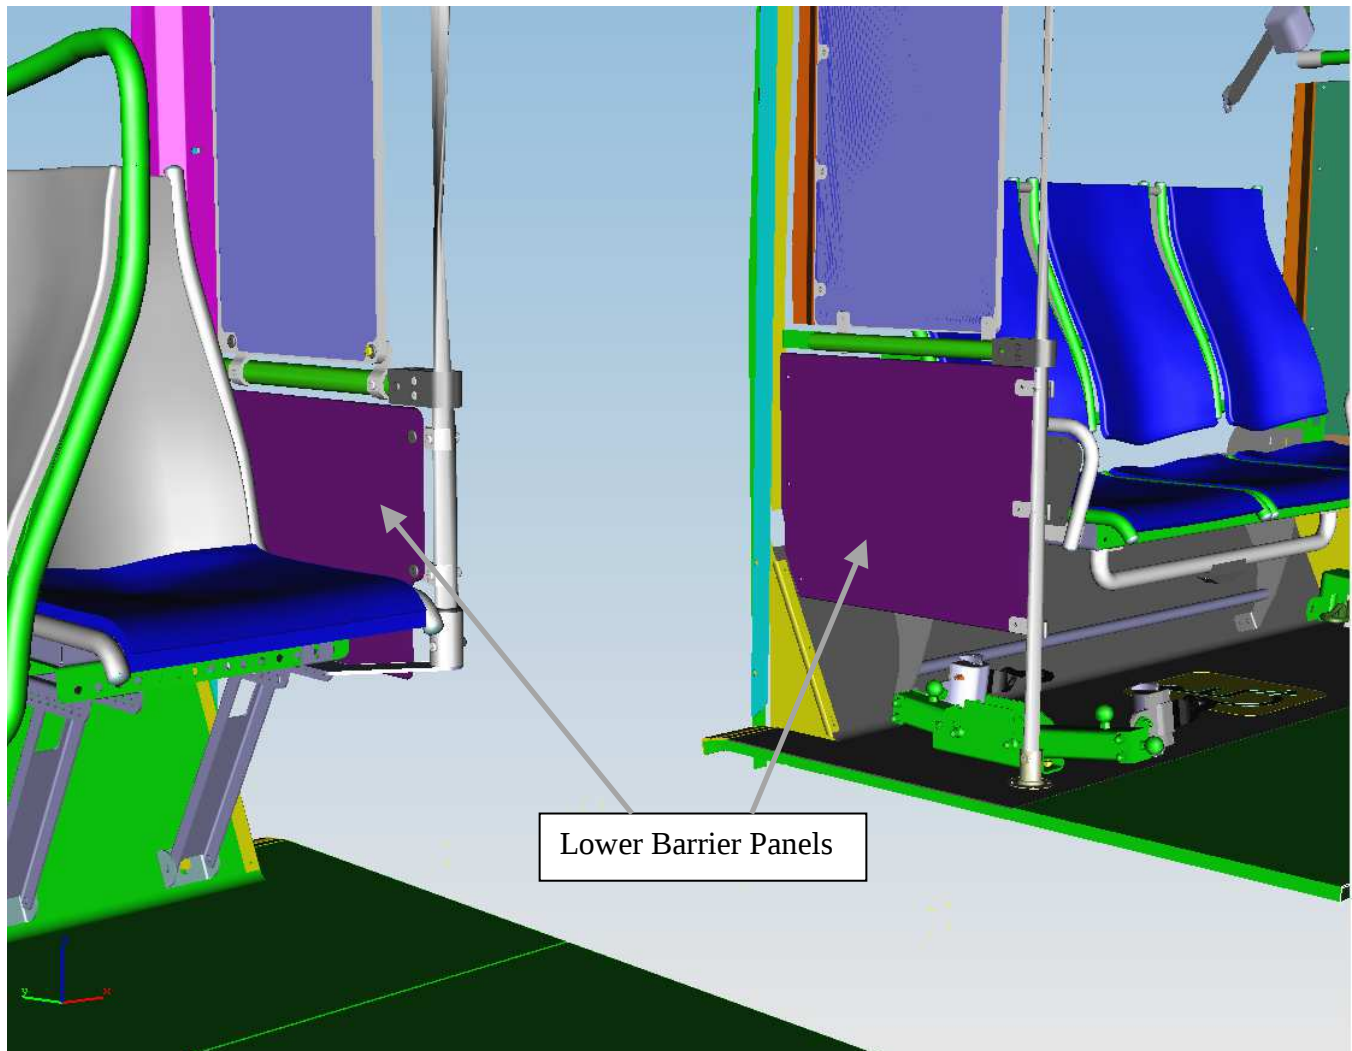
**Figure 1: Barrier panels at rear exit door.**

1. Turn the main battery disconnect switch to the “OFF” position.
2. Remove the existing lower barrier panels from the bus, located forward and rearward of the exit door. Retain hardware for re-use.

3. Install the new forward barrier panel (NF PN 547905) in the location the previous one was in. Secure with existing hardware. Apply 1 to 2 drops of Loctite to threads of hardware prior to securing.
4. Install the new rear barrier panel (NF PN 547900) in the location the previous one was in. Secure with existing hardware. Apply 1 to 2 drops of Loctite to threads of hardware prior to securing.
5. Remove all tools and debris and return the bus to service condition.
6. Turn the main battery disconnect switch to the “ON” position.
