## DART Class Wire Grommet

**Property name and Top bus number:** DART - 304500

**Issue:** Vapor Class System wires being frayed at pass through hole.

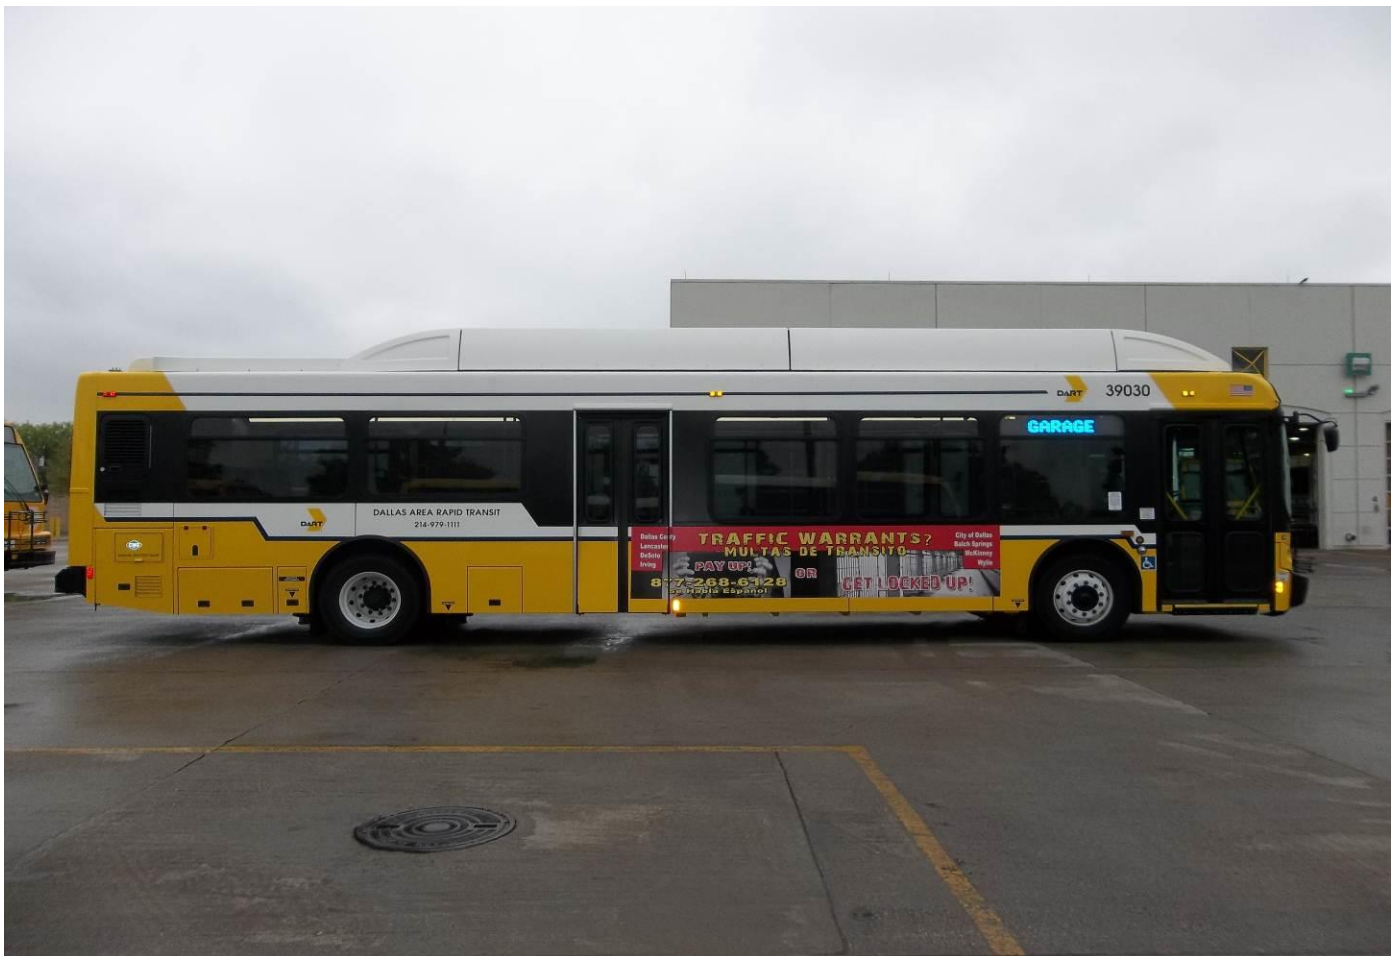
**Reason/ cause:** Loom does not stay in position.

**Solution:** Add grommet
