Field Modification Instructions

FMI # SU2013-1

Subject: Discharge Anaconda line for NABI CNG 40ft and 31ft

- **Part # 800.219.1C.HP**

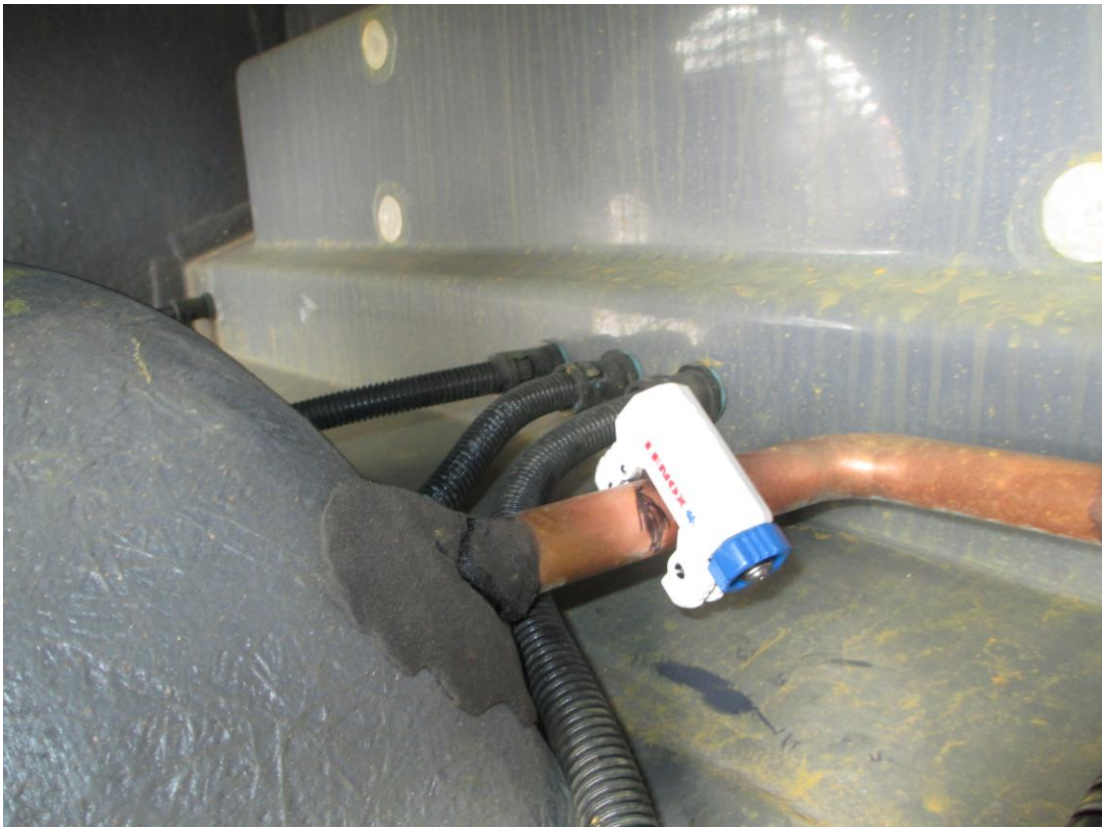
A large number of buses have developed refrigeration leaks at the compressor discharge anaconda line. The purpose of this **FMI** is to change the Discharge Anaconda line assembly with the correct 1.39 Anaconda line on the remaining Buses that have the smaller 1.25 Anaconda.

- 1- Turn off the bus and key switch at A/C distribution box.
- 2- Remove Compressor cover
- 3- Remove curbside condenser fan
- 4- Install refrigerant gauges at compressor
- 5- Isolate the discharge anaconda line by closing the Suction service valve at compressor and the service valve by the condenser check valve.

- 6- Apply 24v to solenoid valve and Recover any refrigerant if present on high side at top service valve for filter dryer.
- 7- Loosen Discharge valve at compressor
- 8- Cut tubing inside unit and tape off to prevent moisture in line.
- 9- Remove discharge anaconda line assembly
- 10- Measure and cut new anaconda line assembly to match the length of the one removed
- 11- Solder a 7/8 coupler on new assembly
- 12- Install new assembly and solder joint inside unit
- 13- Install R134a adapter fitting and high pressure switch from old assembly
- 14- Open Suction service valve
- 15- Open service valve at condenser
- 16- Vacuum from service valve above filter dryer for approx 1 hr
- 17- Add 134a refrigerant as needed
- 18- Turn on key at A/C distribution box
- 19- Start bus and run A/C for approx 30 minutes
- 20- Add 134a refrigerant as need until ball in receiver is $\frac{3}{4}$ to full
