Date	Expiration	Release	Page
09.2014	09.2016	0	1(6)

TRANSMISSION RETARDER LOGIC CHANGE Prevost vehicles

On the vehicles affected by this bulletin, a 7psi pressure switch must be added to the transmission retarder circuit to activate the retarder when vehicle brakes are applied, increasing drivetrain components reliability.

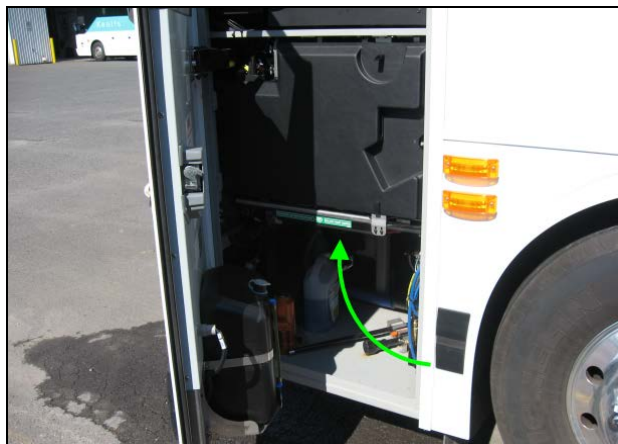
Fig.1 Pressure switches and module location

1. In the front vehicle compartment, locate the transmission retarder pressure switches and module. The switches are located on the superior (top) part of the bottom compartment (Fig.1 & Fig.2).

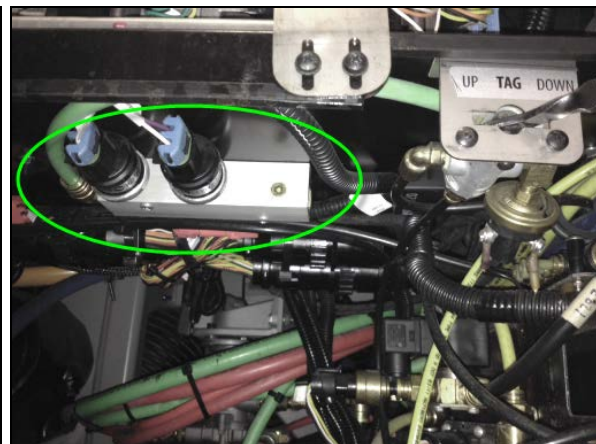
Fig.2 Switches and junction block

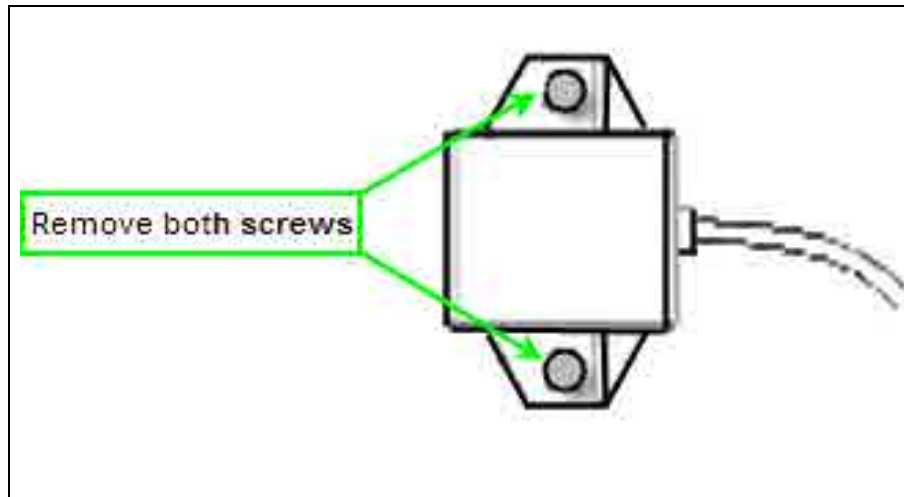
Fig.3 Removing the module

2. Disconnect the two pressure switches from the module.
3. Using a 5/16" hex socket, unscrew the two (2) module retaining hex screws and remove the module from the vehicle (Fig.3).

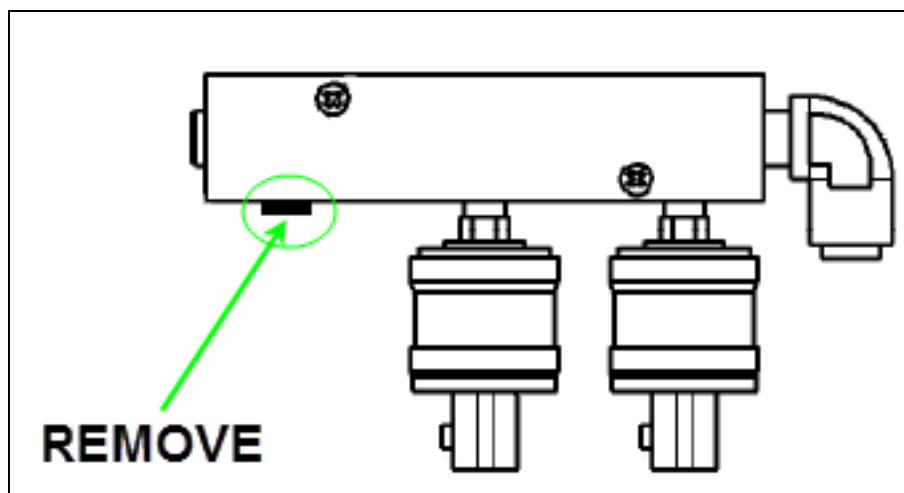
Fig.4 Third port on the junction block

4. Using a 3/16" Allen hex key, Remove the plug that caps the third port of the pressure switches junction block (Fig.4).

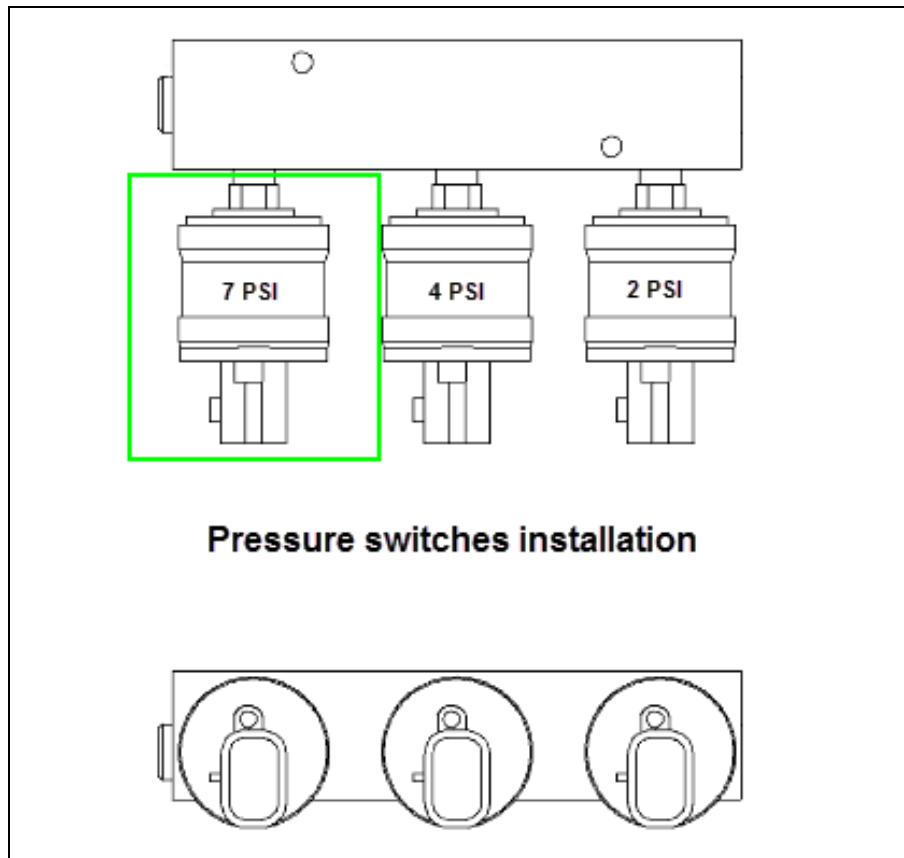
Fig.5 7 PSI pressure switch installed at junction block

5. Install a new 7 psi pressure valve (part# 562385) in the third port on the junction block using Loctite 567 thread sealant (#680098) or equivalent on the pressure switch threads. The pressure switch must be first hand tightened in the junction block then tightened another 1 to 1 ½ final turn using a 1/2" wrench (Fig.5).

NOTE: Make sure the pressure switch connector lines up with the other two pressure switches.

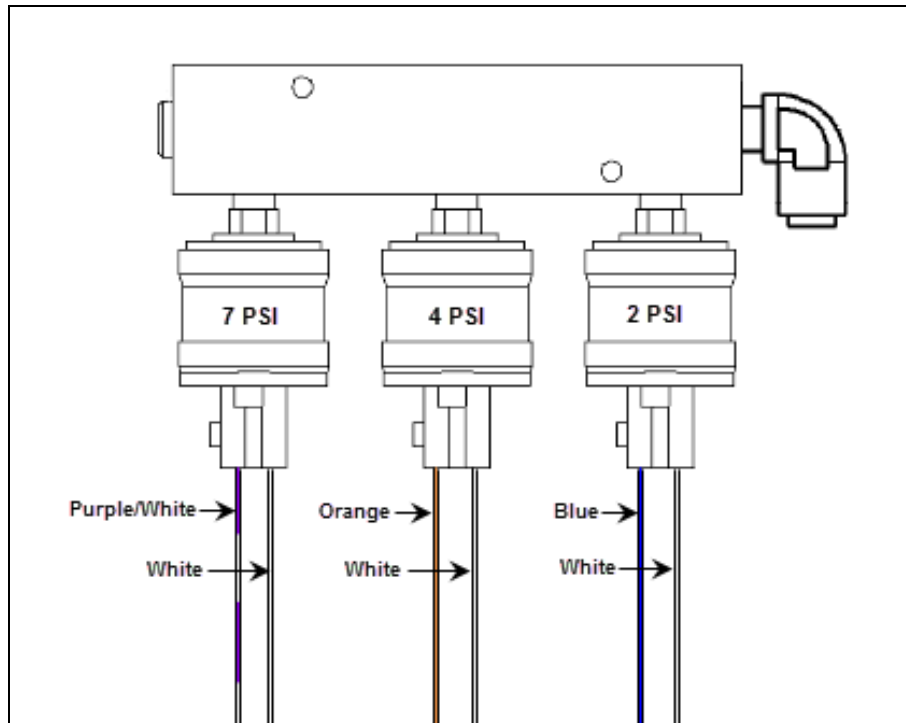
Fig.6 Color identification of the connectors

7. Connect the three (3) pressure switches to the new module (Fig.6 and Fig.7).

The three pressure switches connectors are identical. Be sure to connect them to their respective pressure switch to ensure correct retarder function. Refer to the connector wire color code shown in Fig.6 for proper connection of the module to the switches

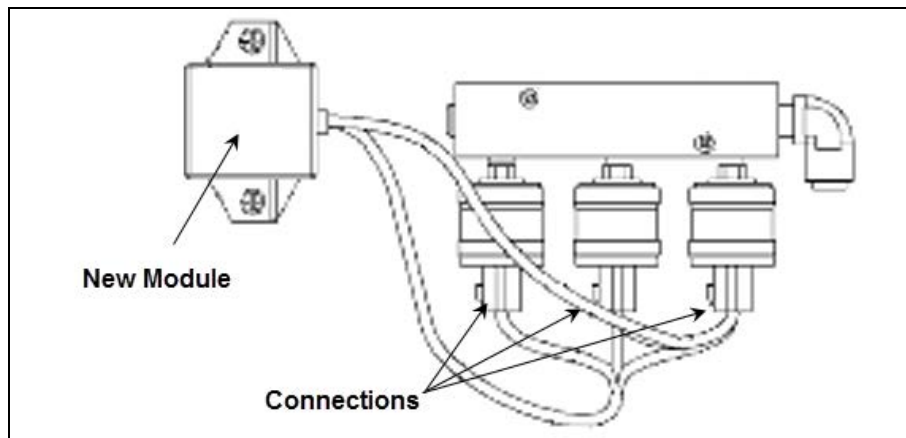
Fig.7 New module connected to pressure switches
