Release 1: This document supersedes previous revisions.
 Nov 10, 2014 Added desired bulb position and MUX software verification.

BITZER COMPRESSOR REMOTE PRESSURE SENSORS AND SWITCH

Prevost vehicles

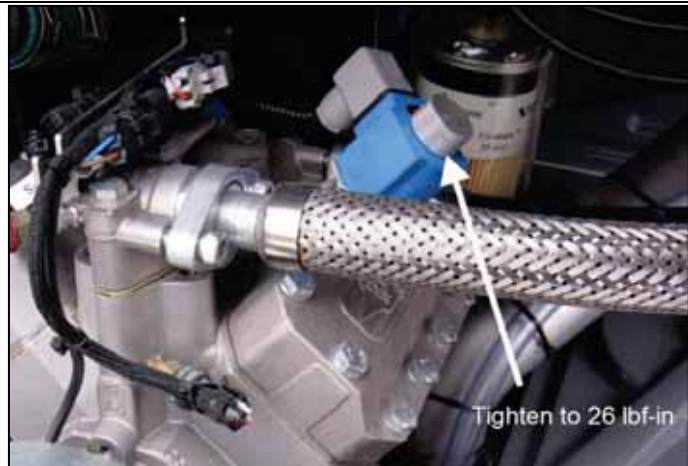
Figure 2

- Connect the refrigerant recovery unit (Fig. 2) and perform refrigerant vacuum.
- Once the system is refrigerant free, close the suction line and discharge valves on the compressor;
- Unscrew the discharge valve cover bolts.
- Inspect and replace the unloader if damaged or defective or if the cap was missing (Step 1).
Order 950513 Kit, Unloader Head

Order **950513** Kit, Unloader Head

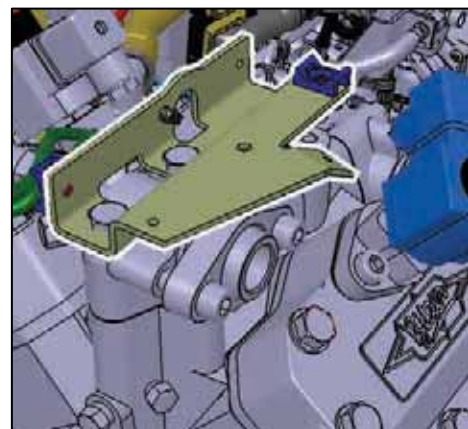
Figure 4

Perform this step if your vehicle has the latest version of the cable management bracket (Fig. 4).

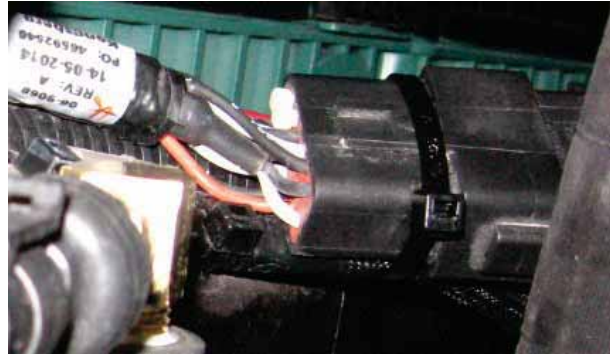
Figure 5 Connector C228

Look on cable management bracket located on the right hand side of the engine. (Fig 5)

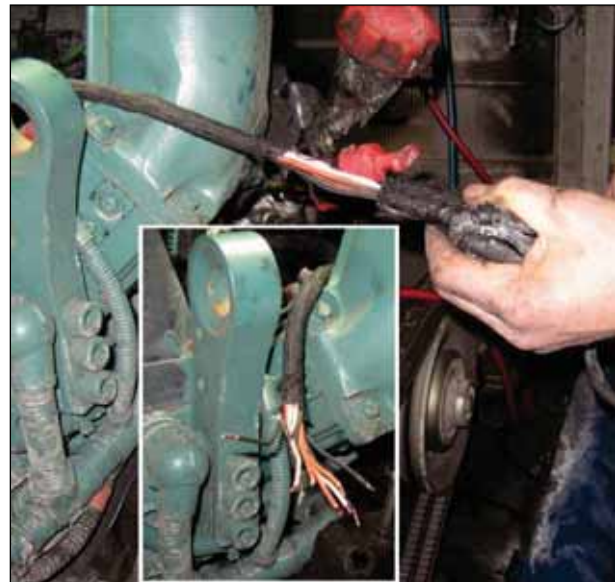
Figure 6 Vehicle harness stripping

On vehicle side, take the main branch leading to the old compressor pigtail. Remove loom, tape above the pigtail junction. (Fig. 6)

Cut two inches (2in.) above junction and strip the wires to install ten (10) Deutsch terminals. See table.

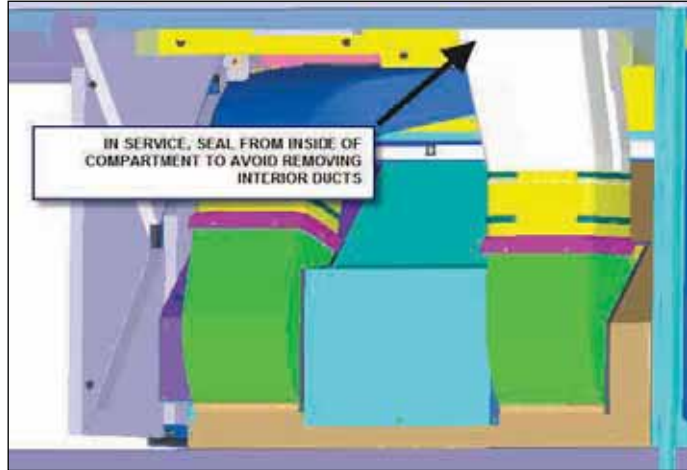
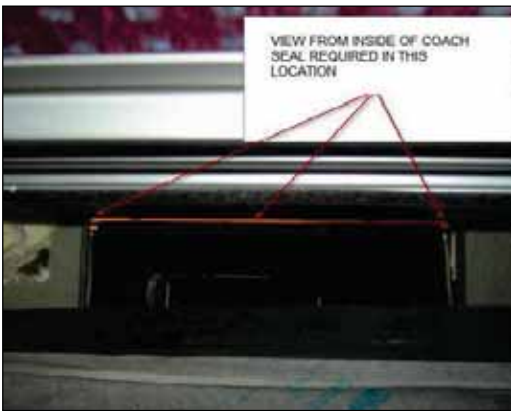
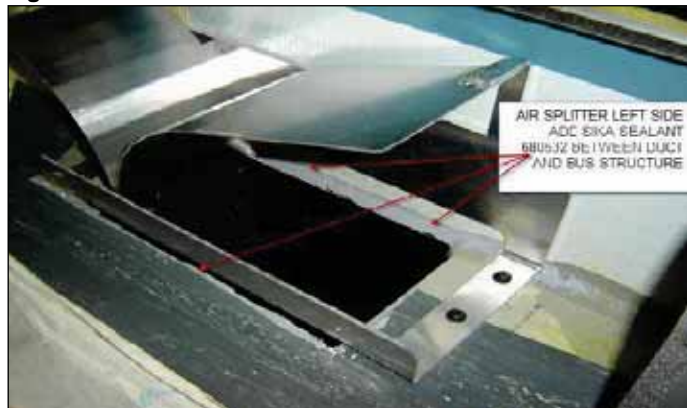
Inspect before performing any work.
Some vehicles up to E-5526 may present a gap between the road side air flow splitter, floor and vehicle structure.

Add a Sika sealant joint #680532 between discharge duct and structure and between duct and floor.
