| Date | Expiration | Release | Page |
|---|---|---|---|
| 12.2014 | 12.2016 | 1 | 1(2) |

## TRANSMISSION OIL COOLER BOLTS Prevost vehicles

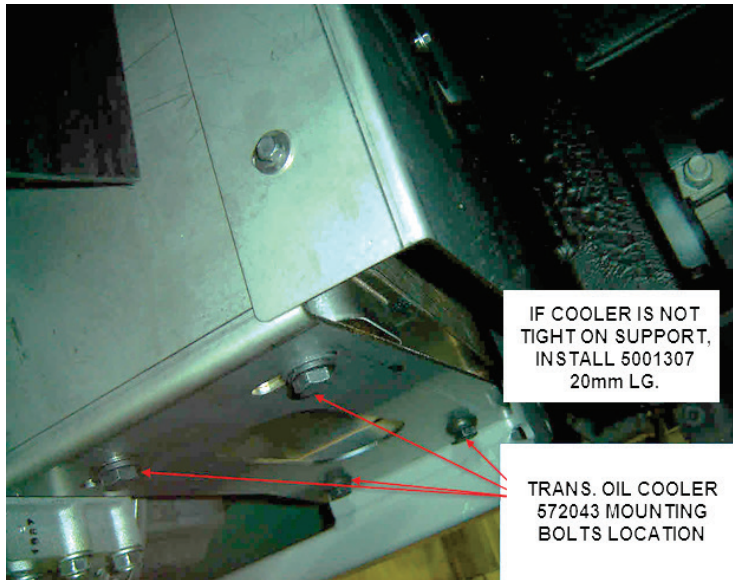
On the vehicles affected by this bulletin, inspect the transmission oil cooler to make sure it is properly secured. In certain material conditions, the bolts may extend beyond the threaded length of the mounting holes in the cooler creating a condition where the support is not tight on the cooler frame. Change the mounting bolts if required.

1. Lift vehicle
2. On the left side of transmission, check that the 4 mounting bolts on the oil cooler properly tighten the cooler on the support bracket.

3. If play is present, change the four (4) mounting bolts for 5001307.
