Service Bulletin

Subject: Roof Beacon Lighting Harness Location

Models: 2015 Chevrolet Silverado

2015 GMC Sierra

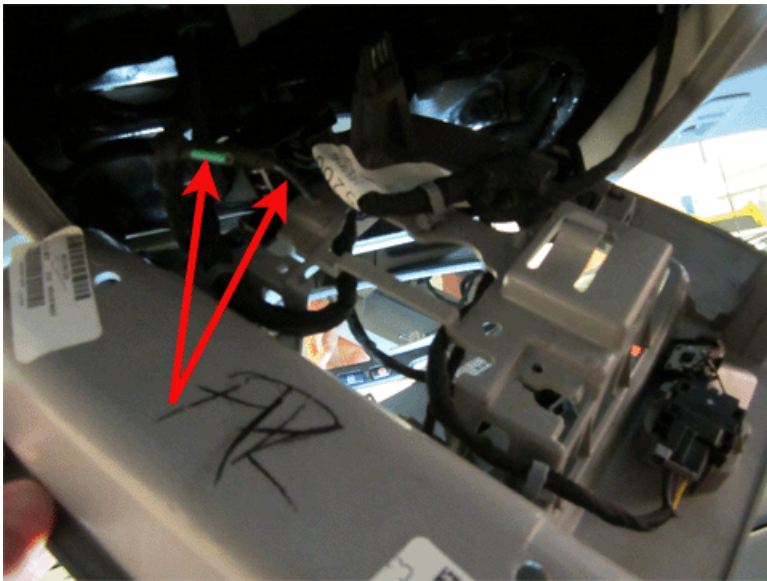
Some owners may question where the blunt cut wires are located for the roof beacon light.

There are two wires located directly above the overhead roof console. Remove the complete overhead roof console and the wires are taped to the harness, as shown below.

Note: The roof beacon relay is located directly above the overhead roof console.
