Bulletin No.: PIP5133B

Subject: 6.6L Duramax Fuel Injection Pump Part Restriction

Models: 2010 - 2015 Chevrolet Express, Silverado

Equipped with the 6.6L Duramax Diesel Engine RPO codes LGH and LML

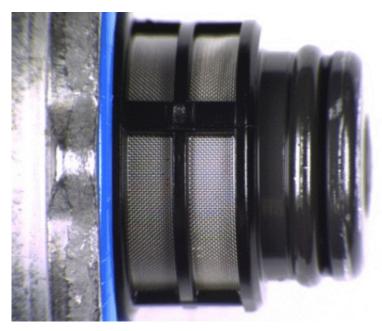
Clean Fuel Pressure Regulator 1 (View A)

If the debris on the Fuel Pressure Regulator compares closest with Group A; more diagnosis is needed. The Fuel Injection Pump is not experiencing the condition described in the latest version of PIP4949.

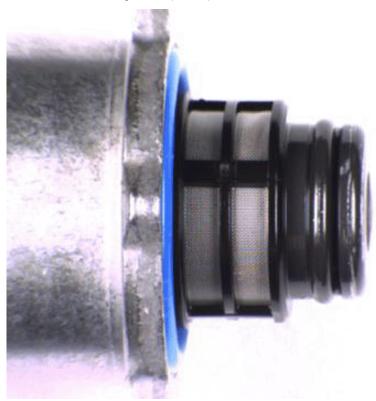
Clean Fuel Pressure Regulator 1 (View B)

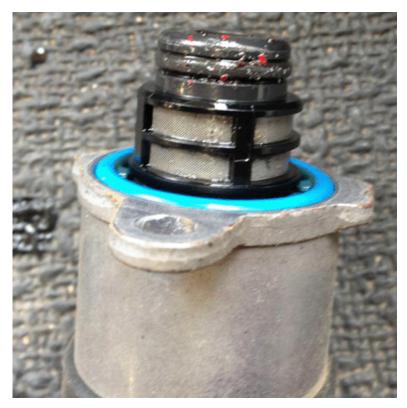
Questionable Fuel Pressure Regulator 1 (View A)

If the debris on the Fuel Pressure Regulator compares closest with Group B; more diagnosis is needed. Remove the Fuel Rail Pressure Sensor and/or Fuel Pressure Regulator 2 (Pressure Relief Valve) for inspection.

- If the same debris is found and the debris is magnetic, the Fuel Injection Pump is experiencing the condition described in the latest version of PIP4949.
 Call PQC to request the Fuel Injection Pump.
- If there is no debris found or non-magnetic debris found, the Fuel Injection Pump is not experiencing the condition described in the latest version of PIP4949.

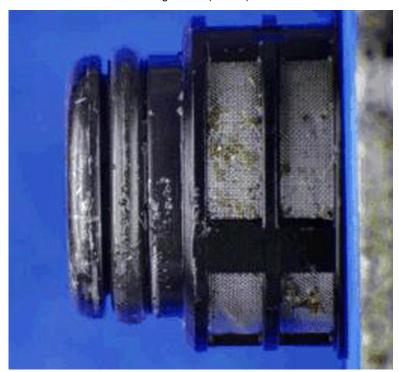
Questionable Fuel Pressure Regulator 1 (View B)

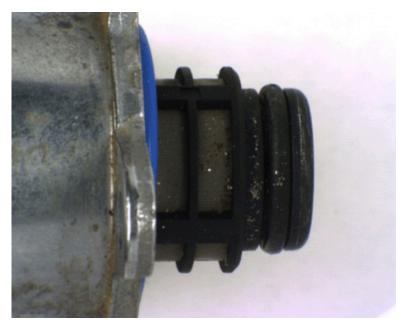
Questionable Fuel Pressure Regulator 1 (View C)

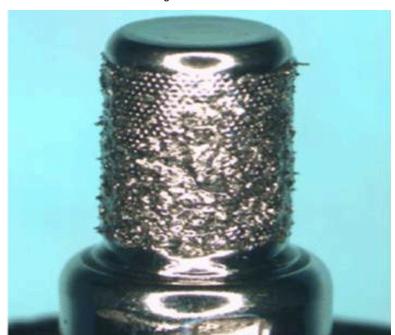
Contaminated Fuel Pressure Regulator 2

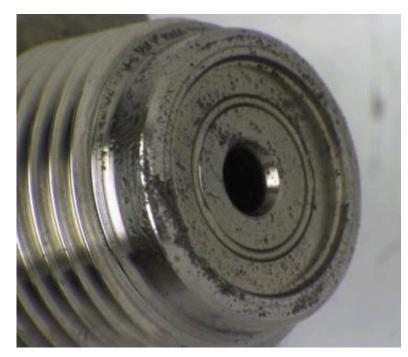
Contaminated Fuel Pressure Sensor

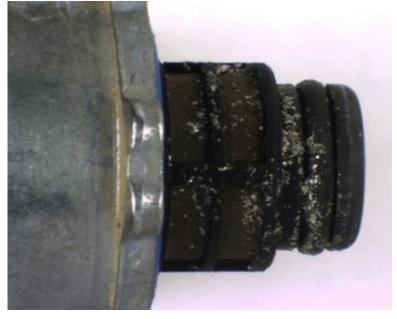
Contaminated Fuel Pressure Regulator 1 (View A)

If the debris on the Fuel Pressure Regulator compares closest with Group C and the debris is magnetic; the Fuel Injection Pump is experiencing the condition described in the latest version of PIP4949. Call the PQC to request the Fuel Injection Pump.

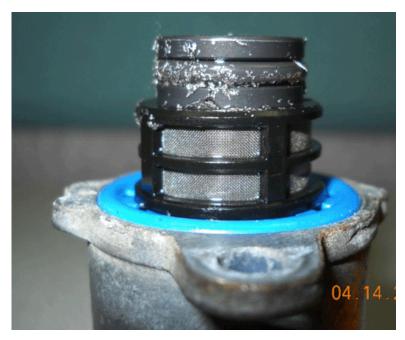
Contaminated Fuel Pressure Regulator 1 (View B)

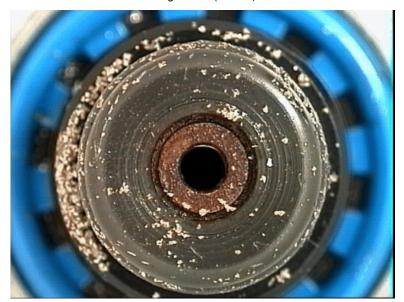
Contaminated Fuel Pressure Regulator 1 (View C)
