# Service Bulletin

**Subject:** Intermittent Map Disc Read Error

**Models:** 2012 Buick Enclave  
2012 Chevrolet Traverse  
2012 GMC Acadia  
Equipped with Navigation Radio RPO U4H or UUM

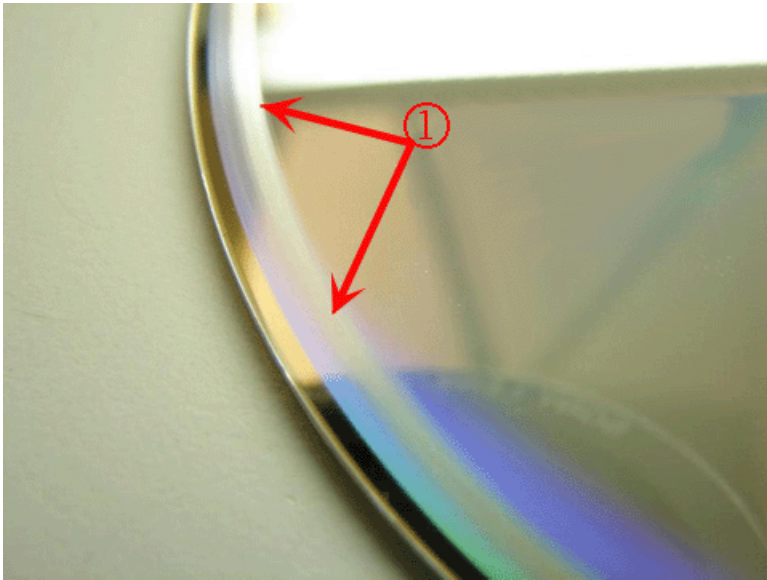
If the disc has concentric scratches near the outer edge please do not install another map disc. Vehicles with this concern will need the radio and map disc replaced. The radio may have an internal fault and cause damage to the new disc. After replacing the radio, please install a test CD or DVD into the map disc slot prior to installing the new map disc (Recommend using a writable CD or DVD). Listen for a rubbing noise and inspect for concentric scratches on the test disc after ejecting. Only install the new map disc if no damage is found on the test disc. Please see below pic (1) for example of concentric scratched disc.

If the map disc is damaged, the disc will need to be replaced. Replacement discs are obtained from the GM NAV DISC center. Please refer to the latest version of 06-08-44-012 if a replacement map disc is required.
