# Service Bulletin

**Subject:** Power Liftgate Erratic Operation Will Not Power Close DTC B153A And/Or Motor Running But Does Not Move

**Models:** 2015 Cadillac Escalade Models  
2015 Chevrolet Tahoe, Suburban  
2015 GMC Yukon Models

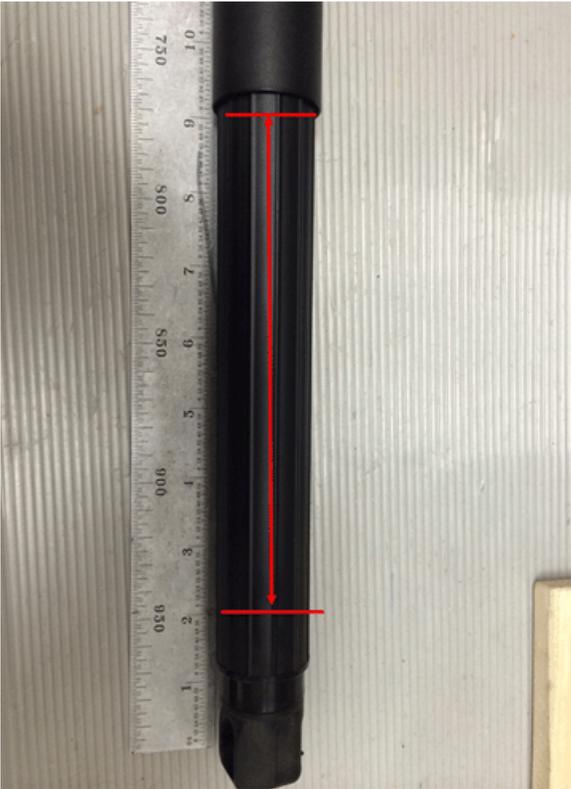
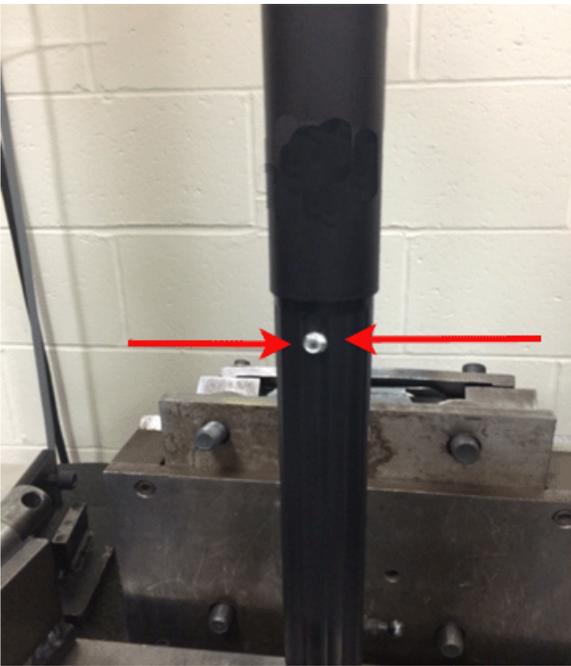
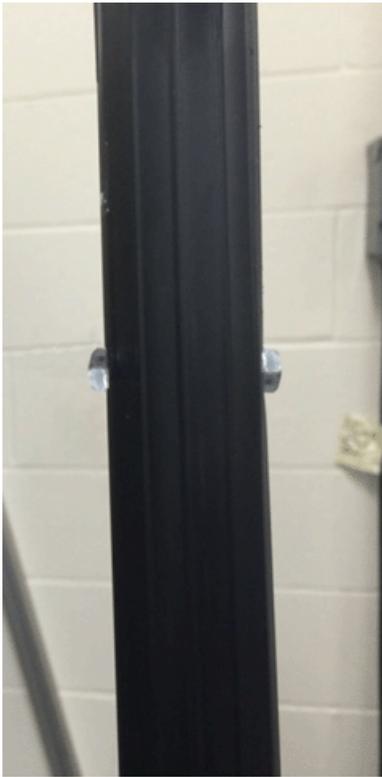
These concerns may occur if the left liftgate strut/motor actuator is internally coming apart. It will need to be replaced, HOWEVER, care must be taken when removing the left liftgate strut/motor actuator from the vehicle. There is an assist spring inside the strut. If the internal portion of the strut has completely separated, and if it is removed from the vehicle without following the procedure listed below, the end of the strut can become a projectile.

1. Obtain two #8 self tapping screws  $\frac{3}{4}$  inches long.
2. Fully open the liftgate.
3. Install the two self tapping screws 180° apart, any place between 2 and 9 inches from the bottom of the left strut, as shown below.

**Note:** The screws will hold the strut together for removal.
