# Service Bulletin

**Subject:** Diagnostic Tip: Radio Center Select Button Is Inoperative On ICS And/Or Touch Screen Is Inop

**Models:** 2013 - 2015 Buick Encore

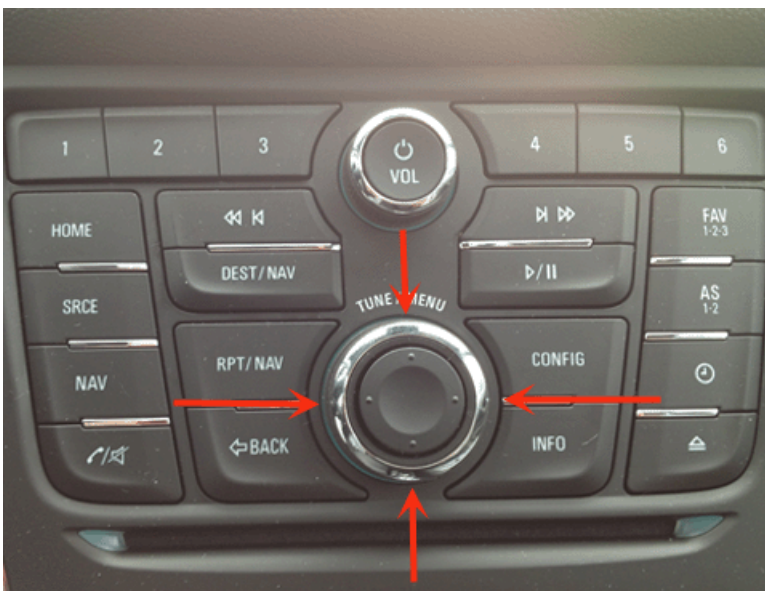
1. All Models:  
The vehicle is not equipped with a touch screen and is not available or offered with such an option.
2. Vehicles with Navigation RPO UHQ Only  
The center Joystick ONLY operates when in the Map Mode. The large chrome dial in the center of the ICS must be used to make a selection then the chrome outer edge needs to be pressed in to make the Selection. See photo below:

**Important:** Do not replace any parts for the concern.
