# Service Bulletin

**Subject:** Creak Or Pop Type Noise Coming From Windshield Area During Cold Ambient Temperatures

**Models:** 2012-2014 Buick Enclave  
2012-2014 Chevrolet Traverse  
2012-2014 GMC Acadia

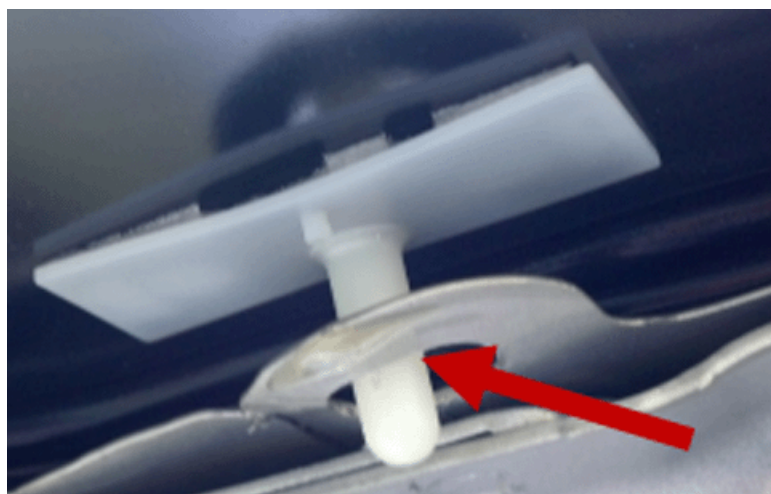
If the noise is coming from the upper windshield area, the condition may be caused by the windshield alignment pins in the upper corners of the glass, 5 inches in from the edge.

The windshield alignment pins are in the upper corners of the glass.

If the noise changes or is gone remove the windshield alignment pins.

If you cannot verify the concern, inspect the windshield alignment pins for rub/wear marks. If the pins shows rub/wear marks on them they will need to be removed.
