# Service Bulletin

**Subject:** Diagnostic Tip - Rear Toe Adjust Link Dampener Service Guidelines

**Models:** 2010 - 2014 Buick Lacrosse (built prior to 02/19/14)  
equipped with 4 Link Rear Suspension (RPO GNC)

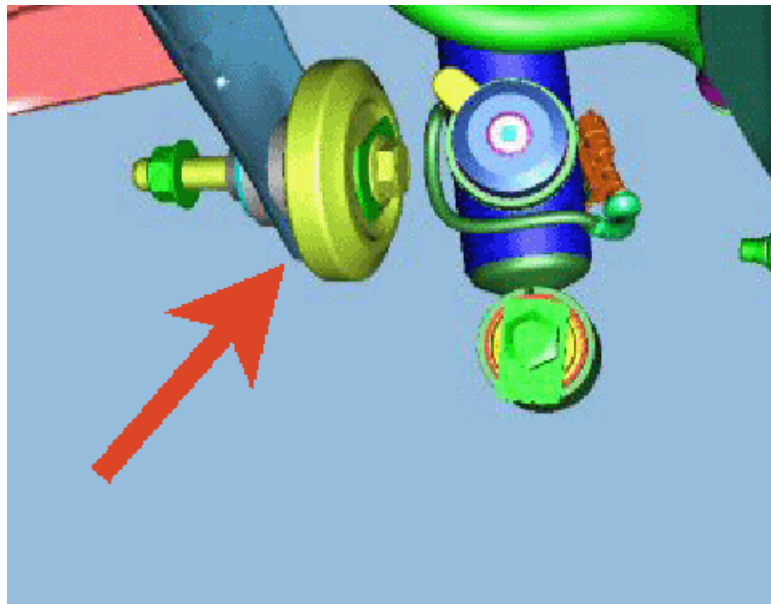
Vehicles listed in the Models section above were built with a dampener on the rear toe adjust link - as reflected in the first image below.

Engineering has determined that this dampener does not make a noticeable impact on noise, vibration, or harshness. Therefore, it has been eliminated from production in February 2014.

If making a repair on a vehicle in which this dampener has been damaged or needs to be replaced, you may remove the dampener and washer and replace with a shorter bolt (GM P/N 11561300). The nut remains the same. Discard the factory-installed dampener and washer.

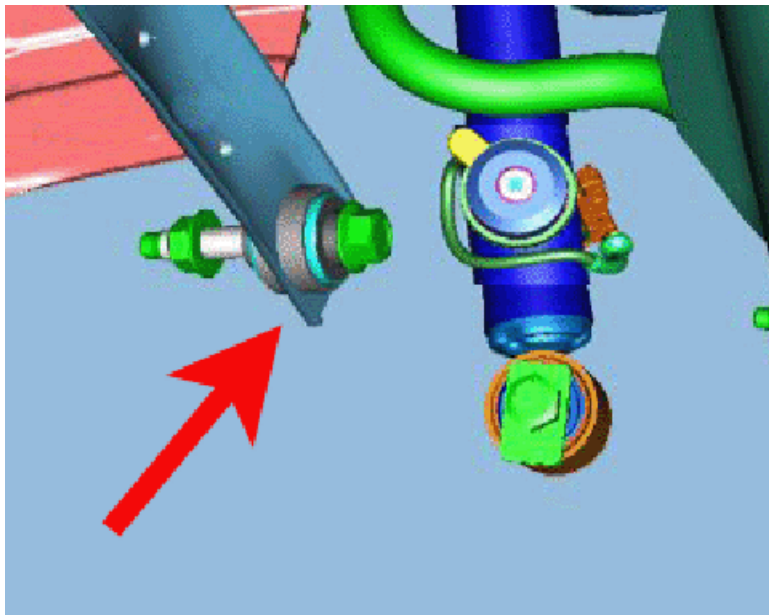
The two photos below show the link with and without the yellow dampener. The second image below shows the shorter bolt without the dampener and washer.
