# Service Bulletin

**Subject:** Rattle Or Buzz Noise From Rear Speaker Or Speakers - Worse With High Bass Levels

**Models:** 2013 - 2014 Cadillac ATS

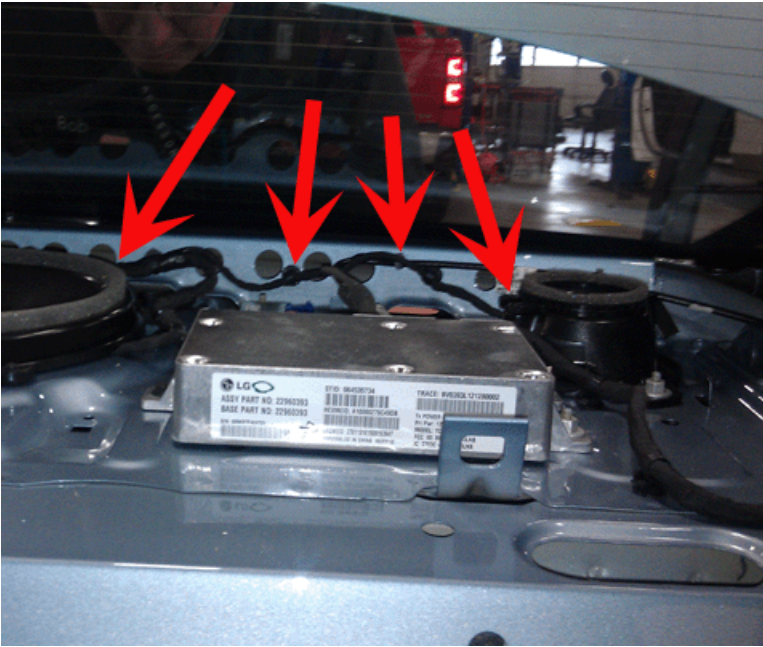
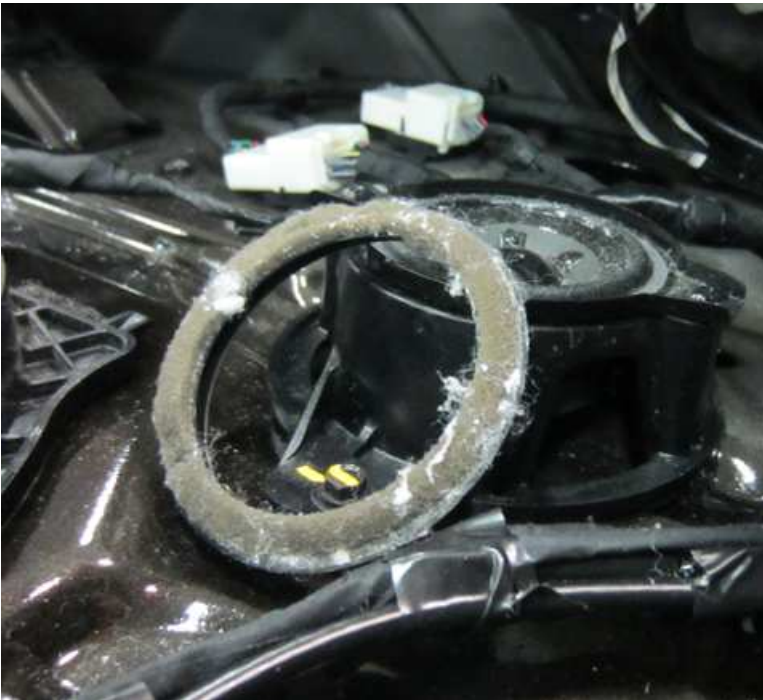
1. Improper speaker mounting or loose trim, wiring harnesses, or other parts may cause an audible buzz or distortion.
2. Rattle or buzz from the OnStar module.
3. Seat belt retractor buzz - Center seat belt retractor bolt may be contacting decklid torque rod inside trunk causing metallic rattle.
4. Child tether cover may be loose in package shelf trim.
5. Package shelf trim and / or trunk upper trim plastic Christmas tree fasteners may buzz to shelf at attachment holes.
6. Leading edge of package shelf, behind rear seat back.
7. Package shelf "J" hooks loose.

1. Inspect the rear speaker and the surrounding interior trim for proper and secure mounting. If the speaker trim has come loose, replace the speaker. If surrounding interior trim is found to be loose or improperly secured, correctly secure the item and add foam to insulate items as needed. Add foam to the subwoofer speaker connector to prevent contact to the under shelf trim from making contact. Use 1/2" by 5/16" of Kent Adhesive Backed Shim Stock (foam) p/n P40125 or equivalent.
