Service Bulletin

PRELIMINARY INFORMATION

Subject: Vehicle Will Not Charge DTC P0D26

Models: 2011-2014 Chevrolet Volt
2014 Cadillac ELR

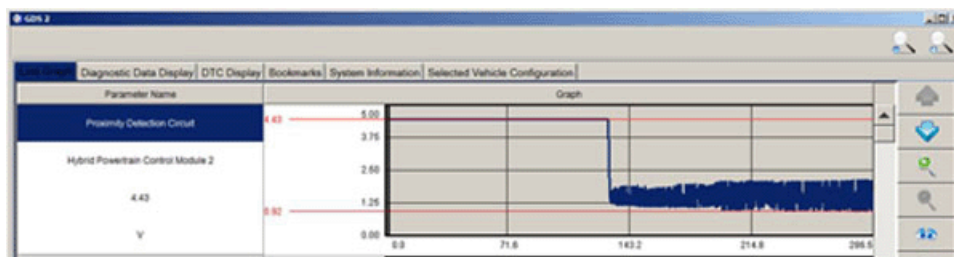
Erratic Signal

6. If your snapshot shows the erratic signal above, and/or the condition changes with charge cord coupler (handle) manipulation, or the proximity signal does not drop to a steady 1.49 volts it will be necessary to inspect the charge port receptacle and wiring.

7. Inspect the charge port receptacle connector for signs of water intrusion or corrosion in both the vehicle harness side and charge port side. If a concern is found it will be necessary to replace the receptacle and repair the harness as needed.
8. If no water or corrosion is found, test the resistance of all the charge port receptacle circuits to each other while disconnected from the OBCM, the HPCM 2 and the charge port receptacle. All circuits should read open, if they do not inspect the harness or connector for a short. Reference SI document 2488859.
9. Check resistance and load test circuits 3837, 3838 and 3952 between the receptacle and the OBCM to isolate any charge cable wiring related concerns.
10. If all of the above do not lead to a resolution continue with the published P0D26 SI diagnostics.
