# Service Bulletin

**Subject:** Installation Tip - Door Striker Cover Installation During PDI

**Models:** 2015 Chevrolet Tahoe LTZ, Suburban LTZ  
2015 GMC Yukon Denali Models

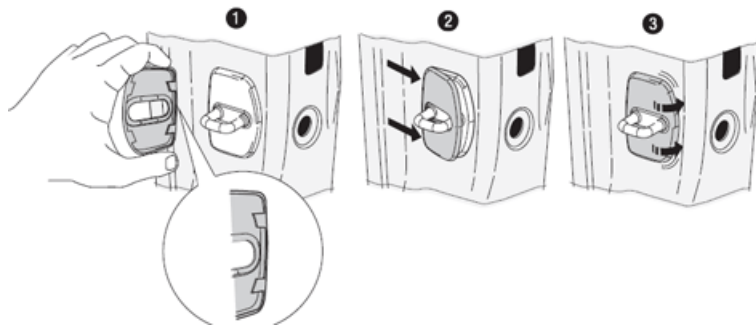
There have been reports of these covers being installed incorrectly / backwards.

Make sure the rounded side of the cover is positioned towards the outboard side of the vehicle, as reflected below:
