# Service Bulletin

**Subject:** Pop Noise From Fuel Tank After a Cold Start or EVAP Purge Event (Equinox / Terrain)

**Models:** 2010 -2014 Chevrolet Equinox  
2010-2014 GMC Terrain

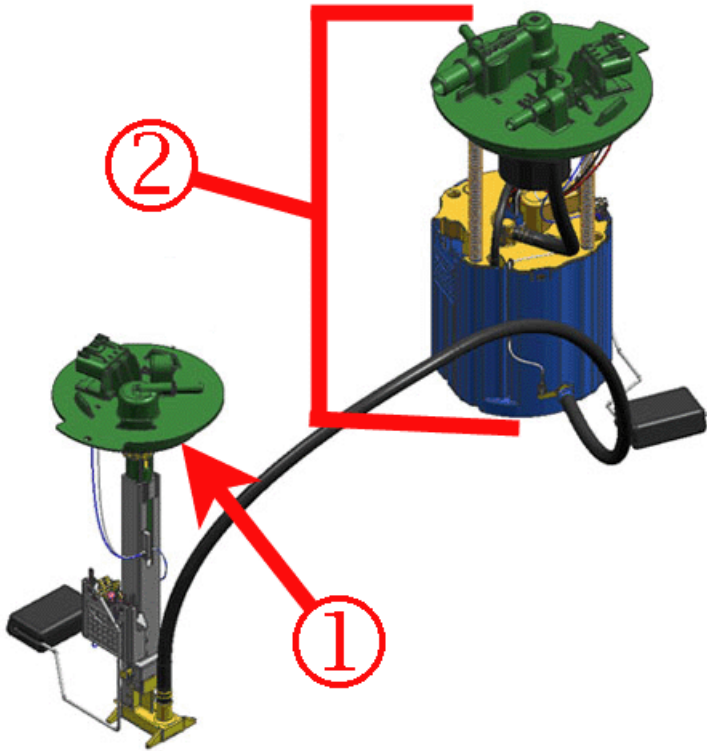
- (1) Flange location of the auxiliary fuel module (sender kit)
- (2) Primary Pump NOT the correct component to replace (module kit)

The part number on the box of the auxiliary fuel module has not changed but the auxiliary fuel module inside of the box has. After ordering the auxiliary fuel module, remove it from the box and verify the letters "PPA" are cast into the top of the fuel module flange. This is the revised auxiliary fuel module designed to correct the pop/popping noise. The original auxiliary fuel module has "POM" cast into the flange.

**Important:** The condition described in this PI applies only to the auxiliary fuel pump module assembly. The Parts Catalog calls this auxiliary pump component the "sender kit" which is the correct part for this repair. Replacing the primary fuel pump module assembly would NOT correct this noise condition. The parts catalog calls this primary pump component the "module kit" which is the incorrect part for this repair.
