Service Bulletin

PRELIMINARY INFORMATION

Subject: Slip Or Shudder During A Launch In First Second Third Or Fourth Gears Delayed Engagement Into Drive Clunk Or Bump During The 1-2 Shift

Models: 2013-2015 Cadillac Escalade
2013 Chevrolet Avalanche
2013-2014 Chevrolet Caprice, Silverado
2014 Chevrolet SS
2013-2015 Chevrolet Suburban, Tahoe
2013-2014 GMC Sierra
2013-2015 GMC Yukon, Yukon XL
Equipped With 6L80 MYC Automatic Transmission

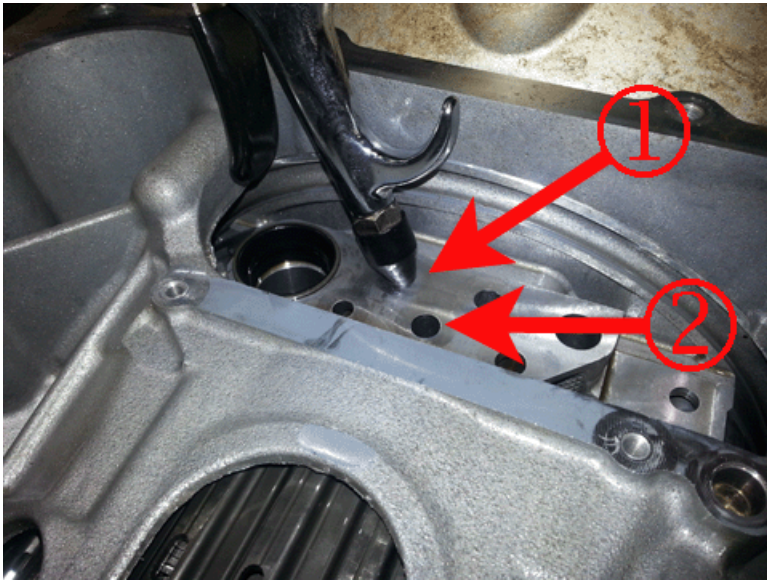
Referring to the picture below apply compressed air to the 1-2-3-4 clutch apply passage and listen for excessive air leakage.

Component Name: Applying compressed air to the 1234 clutch passage.

Component Name: Compensator feed passage.

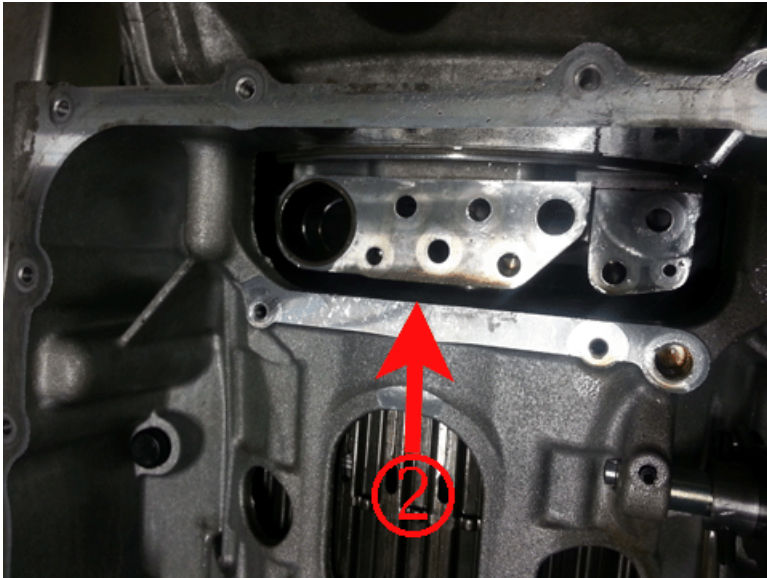
You may also notice fluid leaking or see a misaligned gasket by looking up through the case opening between the pump stator support and the 1234/35R clutch housing during this test as shown below.

Component Name: Gap between the pump cover and the 1234/35R clutch housing.

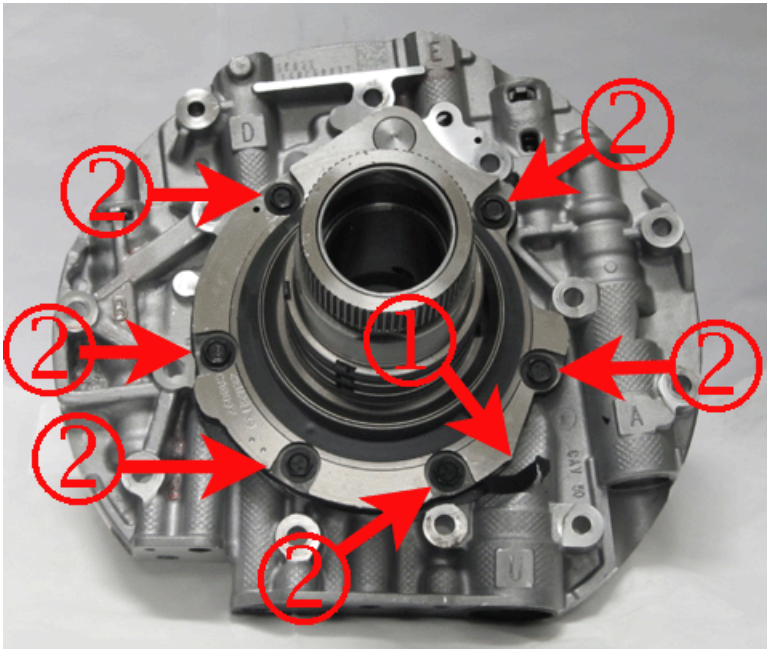
If excessive air leakage is found, inspect the transmission fluid pump for loose stator support to pump cover bolts or a misaligned located stator support to pump cover gasket.

Component Name: Misaligned Gasket

Component Name: Stator Support Bolts

If any of the bolts are loose or the gasket is misaligned or leaking the transmission pump cover must be replaced and the 1234 clutch plates should be inspected for being distressed and repaired as needed.
