Service Bulletin

PRELIMINARY INFORMATION

Subject: During PDI - Inspect The Front Park Halo Ring Light Operation

Models: 2015 GMC Yukon Models

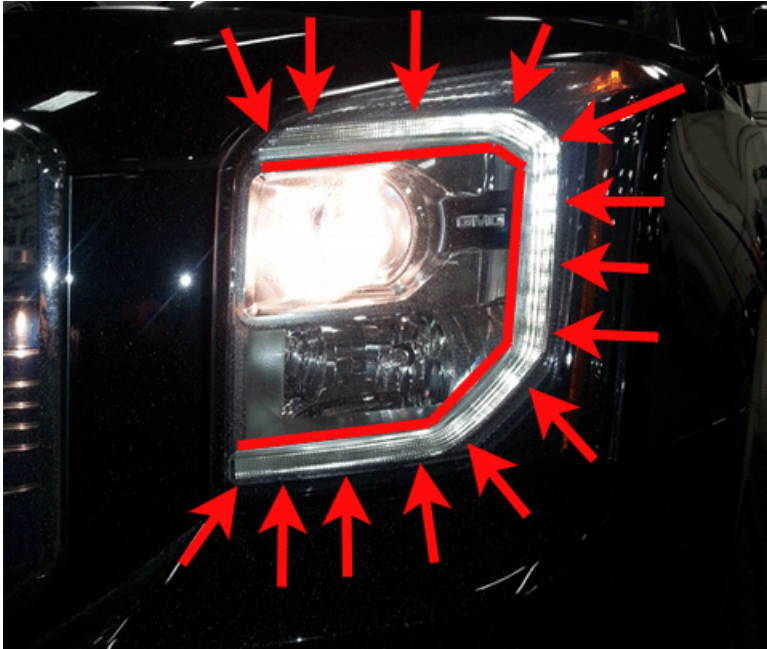
Part of the PDI inspection is to make sure all lighting is functioning properly. While performing the PDI, please make sure to check the front park halo ring lights for proper operation, shown below. The lights should be on steady with no flickering or erratic operation.

To inspect the halo ring light operation, perform a cold engine start and turn on the headlight switch to the "park" or "headlight" position. Make sure the left and right front park halo ring lights stay on steady. If any of the halo ring lights flicker or operate erratically, perform normal diagnostics. If root cause cannot be determined, replace the affected headlight.
