Service Bulletin

Subject: SES Light With A P2097 Or P2099

Models: 2009-2014 Buick Enclave
2010-2014 Buick LaCrosse
2013-2014 Cadillac ATS
2004-2013 Cadillac CTS
2004-2014 Cadillac SRX
2005-2011 Cadillac STS
2013-2014 Cadillac XTS
2010-2014 Chevrolet Camaro
2008-2014 Chevrolet Equinox
2009-2014 Chevrolet Traverse
2009-2014 GMC Acadia
2010-2014 GMC Terrain
2008-2009 Pontiac G8
2008-2009 Pontiac Torrent
2009-2010 Saturn Outlook
With HFV6 engine

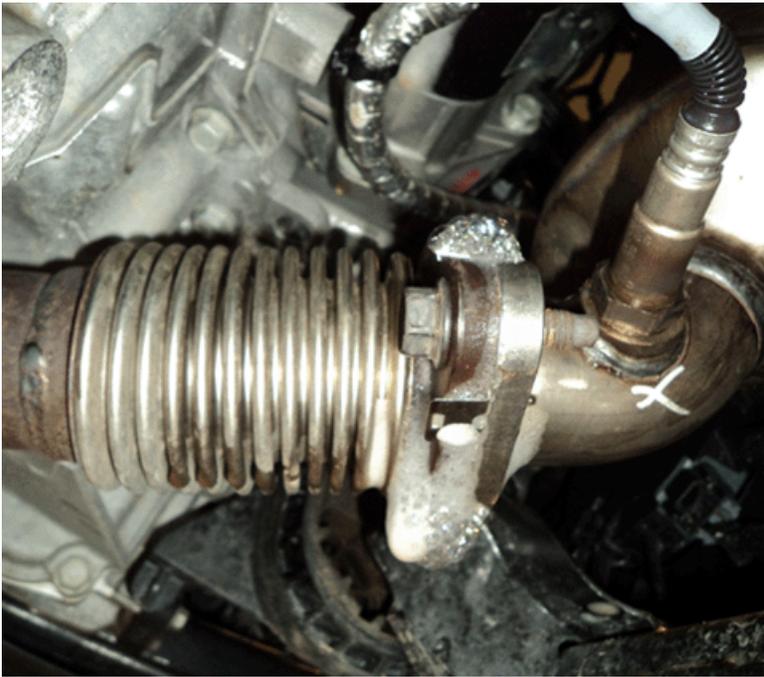
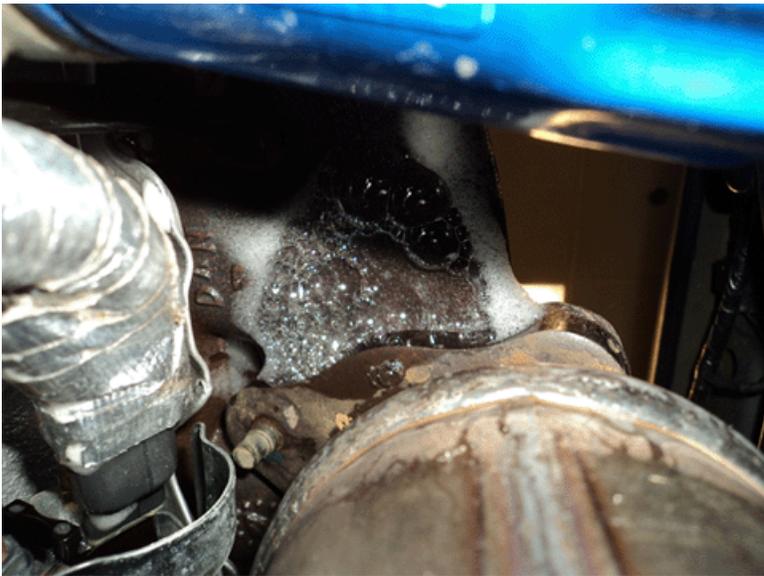
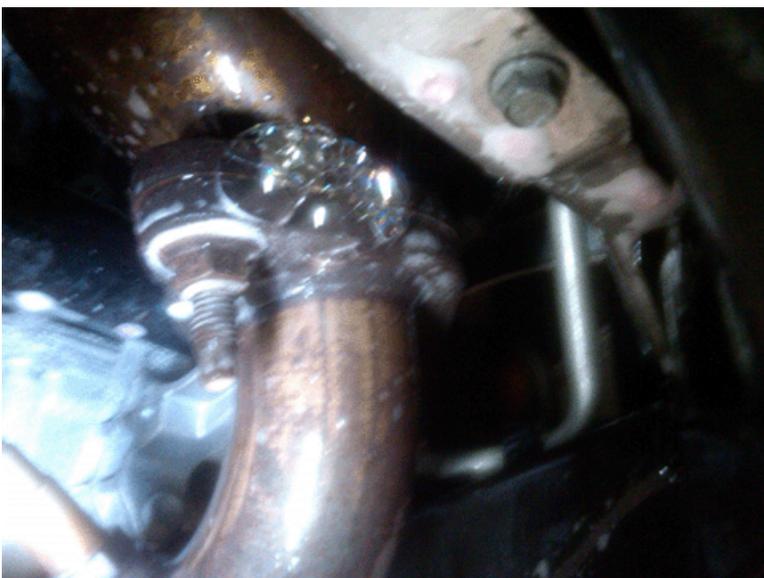
Apply a soapy solution to the gasket areas and the O2 boss.

Leaks in these areas that will cause the code will be larger bubbles.

To diagnose this leak we recommend applying air to the rear of the downstream converter or to the tail pipe on single systems @ 5psi to 8 psi.

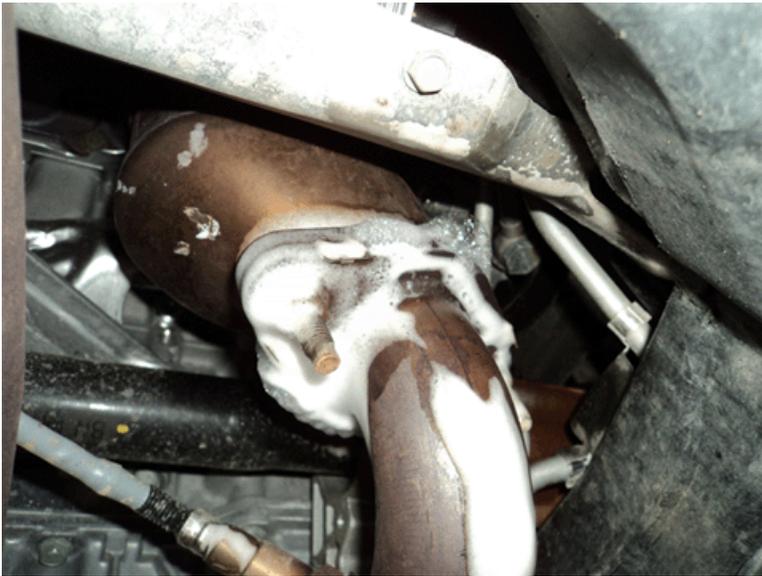
Foam leaks are considered normal.

DO NOT APPLY FULL SHOP AIR as converter and engine damage can result.
