# Service Bulletin

**Subject:** HVAC Blower Motor Is Noisy Or Vibrates

**Models:** 2014 Chevrolet Silverado 1500  
2014 GMC Sierra 1500

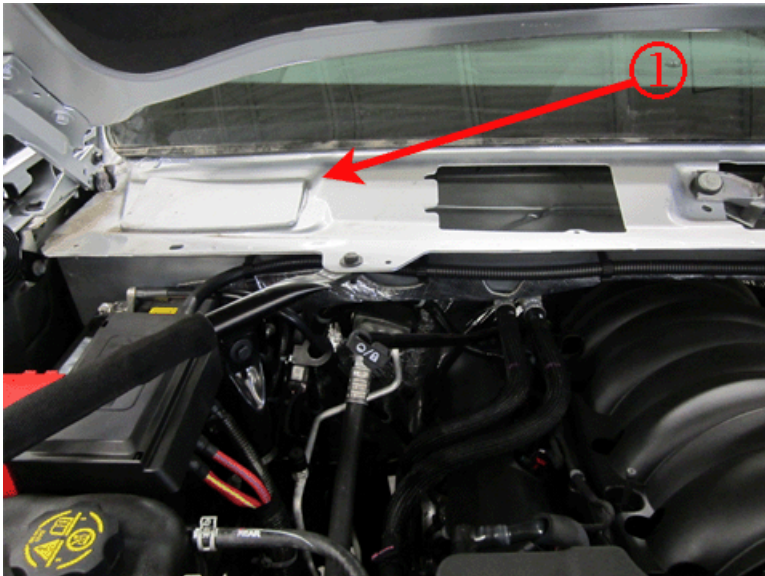
Some owners may comment that when the HVAC blower motor is running, it is noisy or may vibrate. This concern will only occur when temperatures are below 32 deg F (0 deg C). If the blower motor is removed while it is still cold, ice may be found on the blower motor cage. If the cabin air filter is removed while still cold, snow and/or ice may be found on the filter. This concern could be caused by either a water leak into the HVAC case or snow ingestion into the HVAC case.

1. Perform normal water testing diagnostics while the HVAC is running (high blower and in fresh/outside air mode). Inspect for any water leaking past the plenum cover cap, as shown below (1). Water could drip off the bottom of the plenum cover cap (1) into the HVAC fresh air inlet, as shown below (2).

2. If water is leaking past the plenum cover cap (1) it will need to be removed and resealed. While the plenum cover cap is removed also complete the next steps to add a low pressure drop fine snow resistant screen over the fresh air inlet to prevent snow ingestion.
3. Install a 12" x 12" snow resistant screen material over the HVAC fresh air inlet (2), as shown below. The water resistant screen can be ordered from Outerwears at [www.outerwears.com](http://www.outerwears.com) or by calling 800-967-3450. When searching for the product on the website, use part number WR12 and then select color Black (WR12BK).
