Service Bulletin

PRELIMINARY INFORMATION

Subject: 4ET50 Electric Drive Unit Service – Rotor B Replacement

Models: 2011-2014 Chevrolet Volt
2014 Cadillac ELR

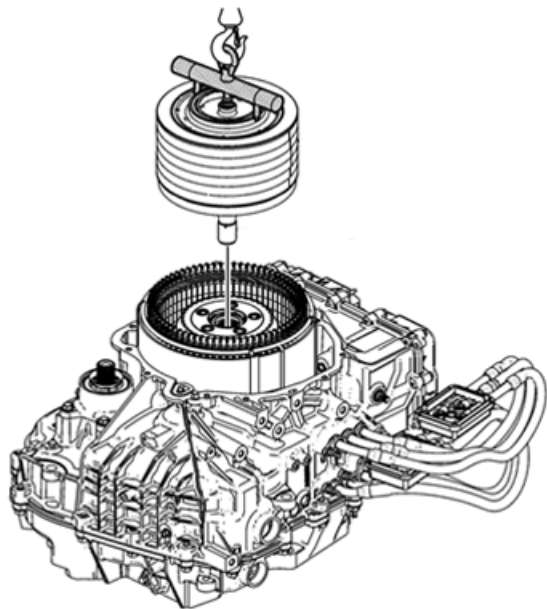
The proper way to address a Rotor B bearing noise is to perform a bearing only replacement per P/I #PIP5081. This can be done on-car.

If this is a repeat repair, and TAC recommends a Rotor B replacement, this must be done off car per S/I.

When replacing the Rotor B Assembly, it is imperative that the technician follows SI (Document ID: 3641026) exactly step by step. The transmission must be removed from the vehicle. Attempts to try this as an on-car procedure will result in subsequent failures and possible transmission damage. Damage or repeat repairs due to not following publish procedures will not be covered by warranty.
