Service Bulletin

Subject: NQG 4WD Models With Noise Vibration On Dry Pavement

Models: 2007-2010 Chevrolet Silverado

2007-2010 GMC Sierra

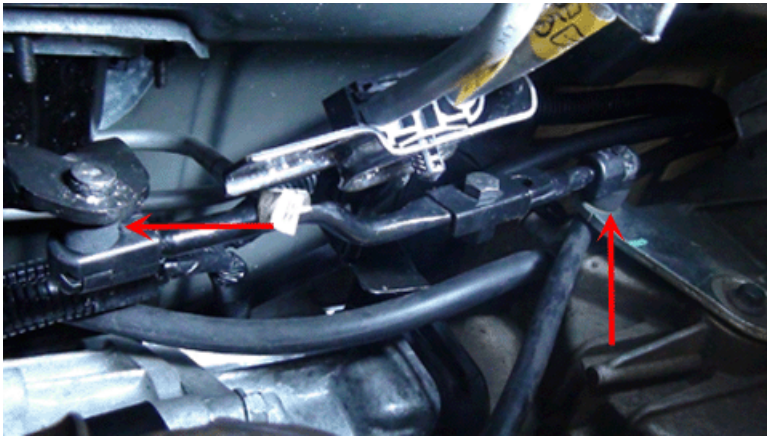
Note: Warranty analysis on nearly every bearing that has been replaced due to customer noise complaints on NQG T-cases have been identified as no trouble found. If the noise heard while in 4wd inside the cab is eliminated by linkage removal then the shift lever is the transfer path for the noise and is an operating characteristic.

The first thing that should be done is to compare with a like vehicle. Ensure that interior content is the same i.e.: both vehicles have carpet or vinyl flooring, same model and both do or do not have plow provisions RPO VYU. Further diagnostics would include shifting the transfer case to 4WD high and then disconnecting the shift linkage from the shift lever, at one of the points shown below, and reevaluating the vehicle operation. If the noise is greatly reduced or eliminated then the shift lever is the transfer path for the noise and is an operating characteristic. No repairs are recommended for this condition.
