# Service Bulletin

**Subject:** Rear Camera Display Blank

**Models:** 2009-2014 Cadillac Escalade Models  
2009-2014 Chevrolet Suburban, Tahoe  
2009-2014 GMC Yukon Models  
With Rear Camera (RPO UVC)

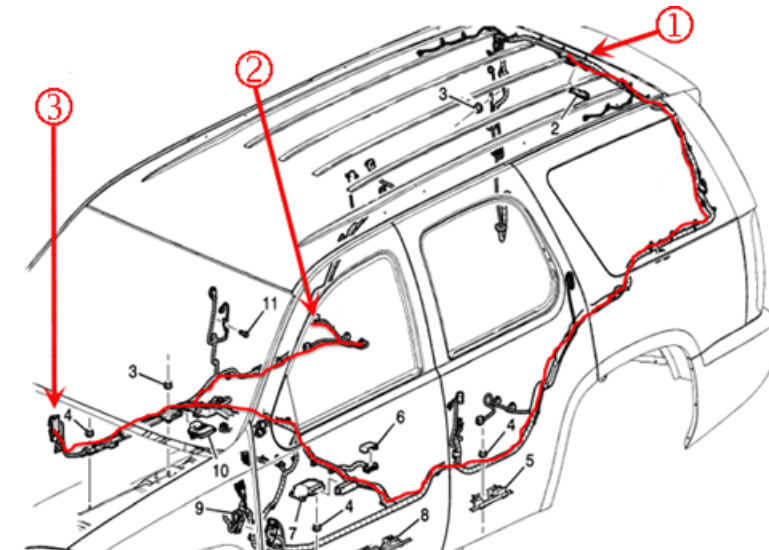
1. X413
2. X421/X322
3. X209

Some customers may comment on a condition with the rear camera display being inoperative when shifting into reverse. This concern could be caused by an open or shorted camera circuit (7641, 7642, and 6799) between the camera and display (Navigation Radio or ISRVM). To help understand the body harness routing of the rear camera circuits, see the picture below. Starting at the liftgate, X413 connects the liftgate harness to the body harness. The body harness runs along the rear of the roof to the driver's side "D" pillar and then down and along the driver's side to the door sill. At the driver's seat, the harness routes across the truck (going under the driver's seat, center console/center seat and passenger seat) to the passenger sill. At the passenger sill, the circuits will either go forward to X209 (if equipped with a Navigation Radio) or rearward to X421/X322 (If equipped with display in the ISRVM).
