Service Bulletin

PRELIMINARY INFORMATION

Subject: Navigation Or Radio Display Blank Or Flashing DTC B1265, B1288 Or B1289

Models: 2007-2014 Cadillac Escalade Models
2007-2013 Chevrolet Avalanche, Silverado, Suburban, Tahoe
2014 Chevrolet Silverado 2500/3500, Suburban, Tahoe
2007-2013 GMC Sierra, Yukon Models
2014 Sierra 2500/3500, Yukon Models

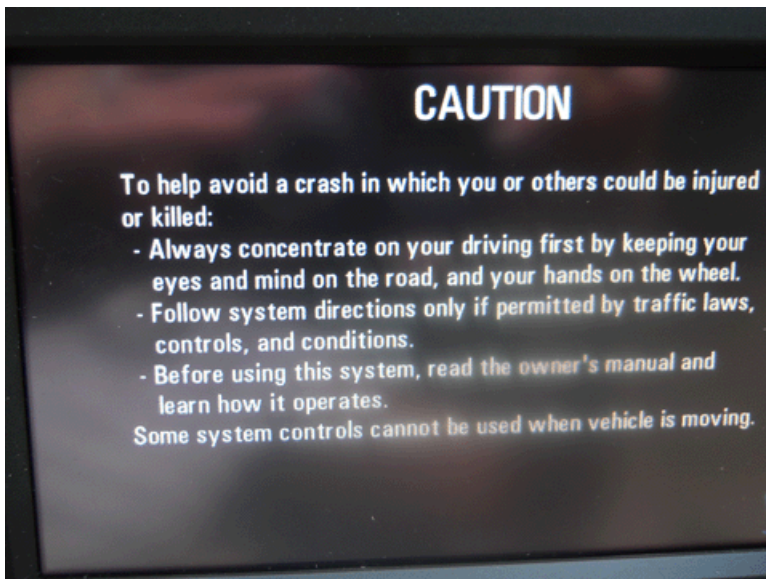
- Navigation or radio screen is blank or flashes on and off
- No sound from speakers
- Rear DVD screen inoperative
- DTC B1265, B1288 Or B1289
- Navigation disclaimer message intermittently will be displayed (see below)

This condition may be caused by the remote enable signal wire circuit 7066 being shorted to ground. This remote enable signal comes from the radio and feeds the Amplifier (except vehicles with RPO Y91 or any 2009 and later Chevrolet Utility equipped with RPO STZ), the antenna module (utilities only), and the rear video display (with RPO U42).

If you experience this concern, check for a short to ground on the remote enable signal wire (Circuit 7066) and repair and re-route the circuit as needed. The most common area of concern is a shorted wiring harness near the rear DVD display screen under the headliner.
