# Service Bulletin

**Subject:** NQG 4WD Models With Noise Vibration On Dry Pavement

**Models:** 2007-2010 Chevrolet Silverado

2007-2010 GMC Sierra

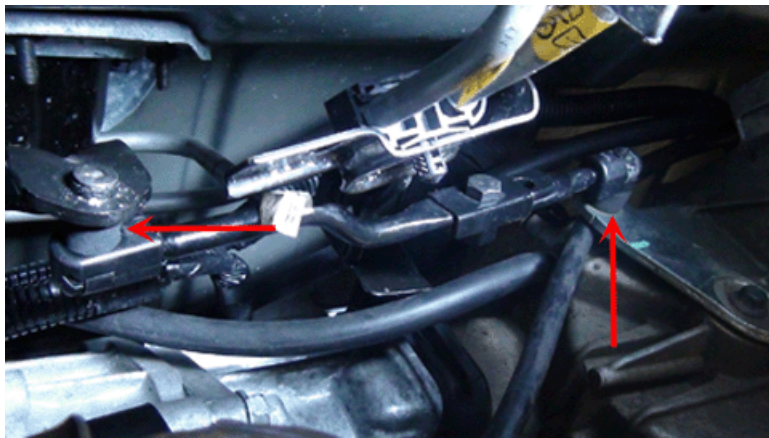
**Note:** Warranty analysis on nearly every bearing that has been replaced due to customer noise complaints on NQG T-cases have been identified as no trouble found. If the noise heard while in 4wd inside the cab is eliminated by linkage removal then the shift lever is the transfer path for the noise and is an operating characteristic.

The first thing that should be done is to compare with a like vehicle. Ensure that interior content is the same i.e.: both vehicles have carpet or vinyl flooring, same model and both do or do not have plow provisions RPO VYU. Further diagnostics would include shifting the transfer case to 4WD high and then disconnecting the shift linkage from the shift lever, at one of the points shown below, and reevaluating the vehicle operation. If the noise is greatly reduced or eliminated then the shift lever is the transfer path for the noise and is an operating characteristic. No repairs are recommended for this condition.
