Service Bulletin

PRELIMINARY INFORMATION

Subject: Engine Running Hot Or Overheating

Models: 2014 Chevrolet Corvette
2014 Chevrolet Silverado 1500
2014 GMC Sierra 1500
Built with RPOs 4.3L 5.3L 6.2L L83 L86 LT1 LV3

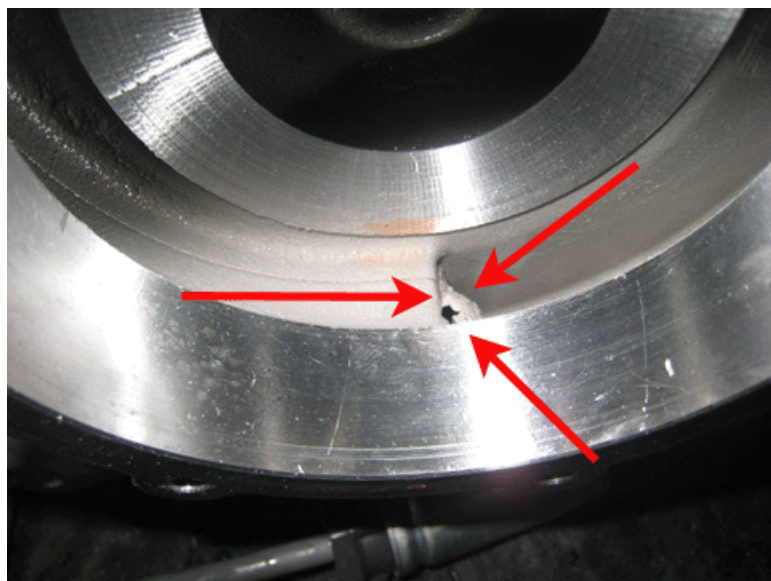
1. Check for hydrocarbons in the cooling system.
2. Check the operation of the thermostat.
3. Inspect the water pump impeller for any sign of concern.
4. Check for a coolant manifold assembly concern, the picture below shows an example of a location where it can be seen. (It could be in other location)
5. If the concern cannot be isolated, replace the coolant manifold assembly (water pump housing).

Note: This may not always be seen in this location.
