Service Bulletin

PRELIMINARY INFORMATION

Subject: Oil Leak from Rear of Engine After Extended Driving in Cold Temperatures Below 0 F (-18 C)

Models: 2010-2014 Buick Lacrosse
2011-2014 Buick Regal
2012-2014 Buick Verano
2013-2014 Chevrolet Captive Sport
2010-2014 Chevrolet Equinox
2010-2013 Chevrolet Malibu
2010-2014 GMC Terrain
with 2.4L Engine (RPO LAF, LEA or LUK)

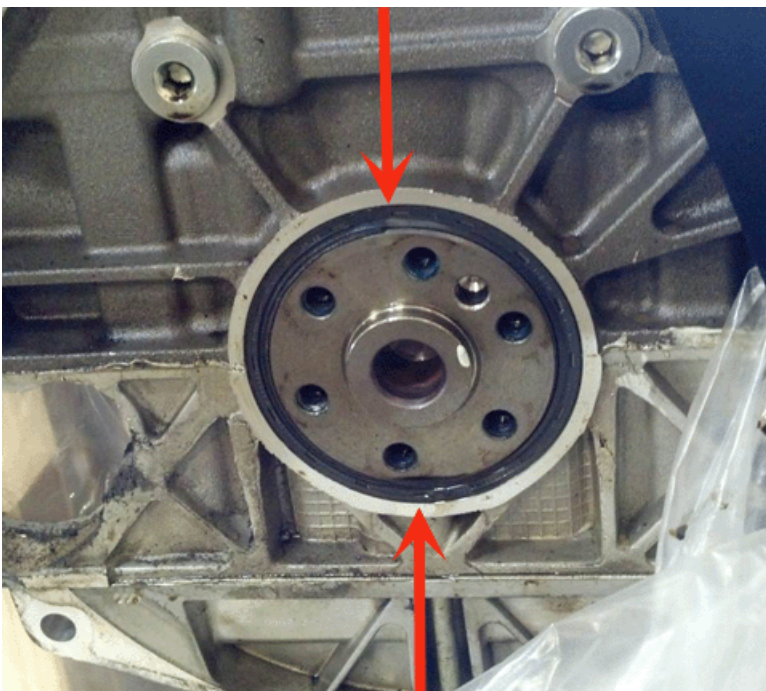
Some customers may complain of an engine oil leak that appeared as they were driving the vehicle in extremely cold ambient temperatures (Generally 0 F / -17 C or Colder). They may also comment that they heard a single "pop" noise right before the oil leak started. Upon inspection, the technician will find that the oil leak is coming from the rear main oil seal of the engine as shown below. This may be the result of a frozen PCV system and excessive crankcase pressure. If a leaking rear main oil seal is found in warmer climates, this PI does not apply.

If this concern is experienced, determine if the concern is the result of a frozen PCV system by inspecting the PCV system, dipstick, and engine oil fill cap for signs of ice, moisture, and/or sludge build up. If this is not due to a frozen PCV system, follow Service Information Procedures to diagnose and repair. If this is the result of a frozen PCV system, follow the steps below:
