Service Bulletin

PRELIMINARY INFORMATION

Subject: Slip Or Shudder During A Launch In First Second Third Or Fourth Gears Delayed Engagement Into Drive Clunk Or Bump During The 1-2 Shift

Equipped With 6L80 MYC Automatic Transmission Built in the Silao Mexico Plant 2

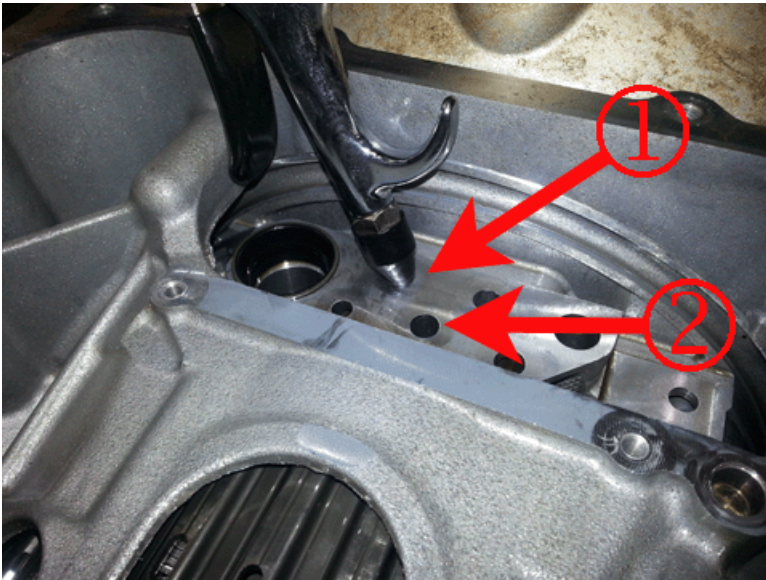
Referring to the picture below and wearing proper eye protection apply compressed air to the 1-2-3-4 clutch apply passage and inspect for air leaking out of the compensator feed passage in the pump cover.

If no leakage is found out of the compensator feed passage listen for excessive air leakage inside the transmission.

Component Name: Applying compressed air to the 1234 clutch passage.

Component Name: Compensator feed passage.

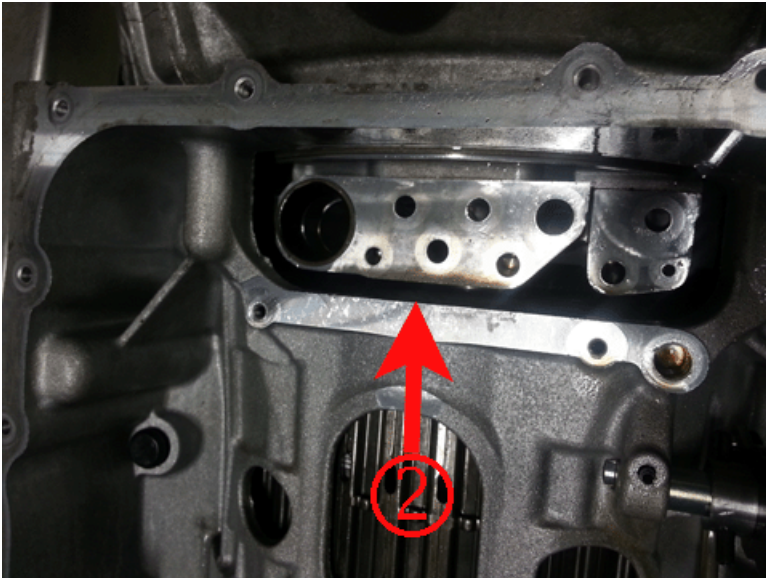
You may also notice fluid leaking or see a misaligned gasket by looking up through the case opening between the pump stator support and the 1234/35R clutch housing during this test as shown below.

Component Name: Gap between the pump cover and the 1234/35R clutch housing.
