# Service Bulletin

## PRELIMINARY INFORMATION

**Subject:** Possible Oil Consumption - Oil Leaks - Blue Smoke From The Exhaust - MIL - Or Fuel Trim Codes

**Models:** 2011 - 2014 Chevrolet Cruze  
2013 - 2014 Buick Encore  
2013 - 2014 Chevrolet Sonic  
2013 - 2014 Chevrolet Trax (Canada Only)  
Equipped with 1.4L (RPO LUJ or LUV)

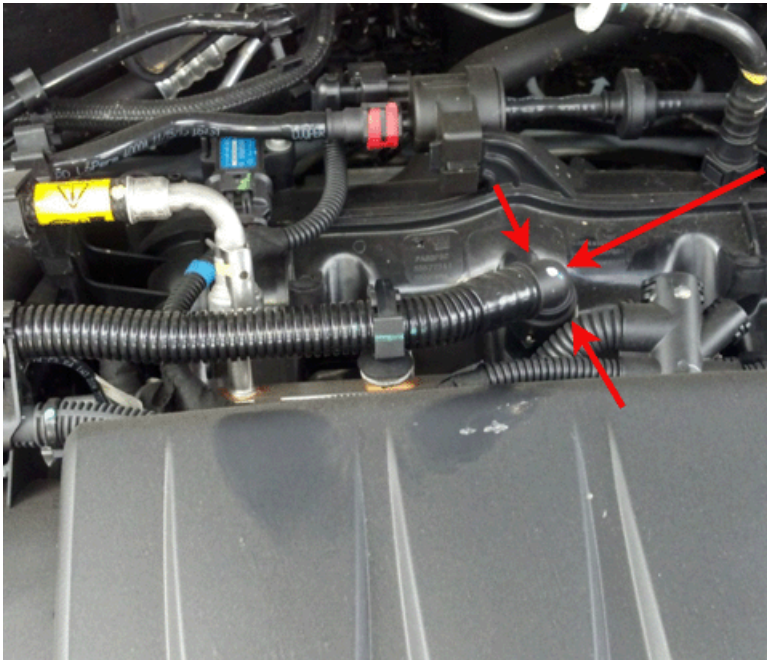
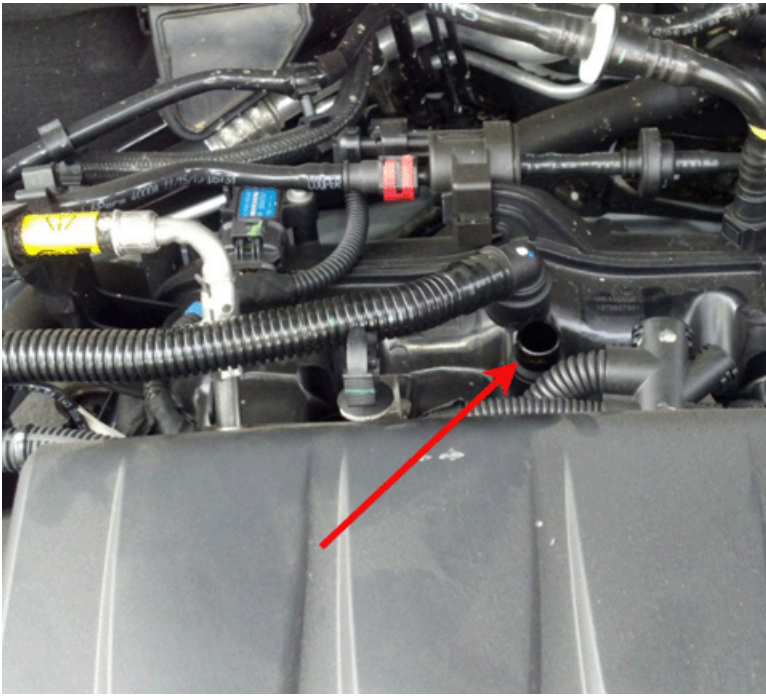
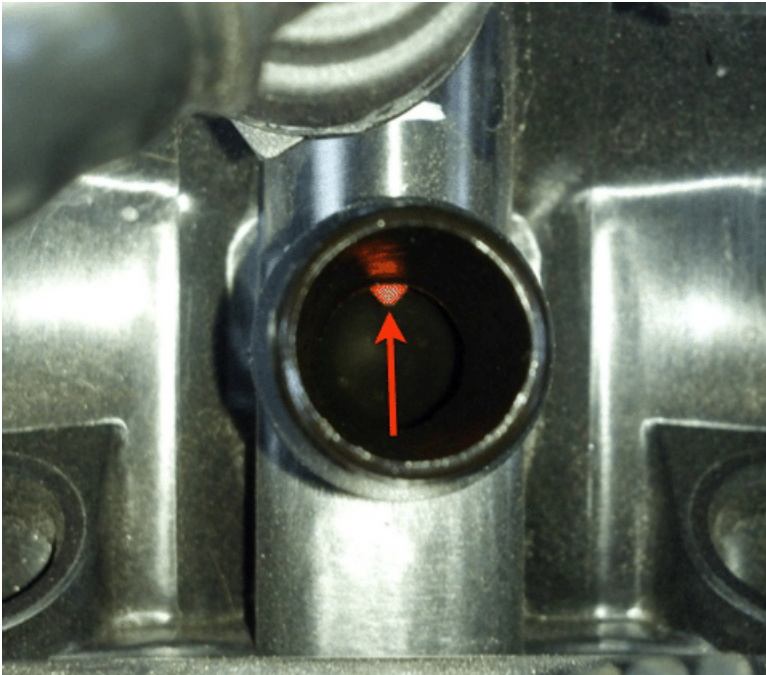
Check for a missing or improperly seated intake manifold Non Return Valve that may have damaged the PCV orifice diaphragm. (See pictures below for inspection procedure).

If the intake manifold Non Return Valve is missing or not properly seated, then replace the intake manifold assembly,

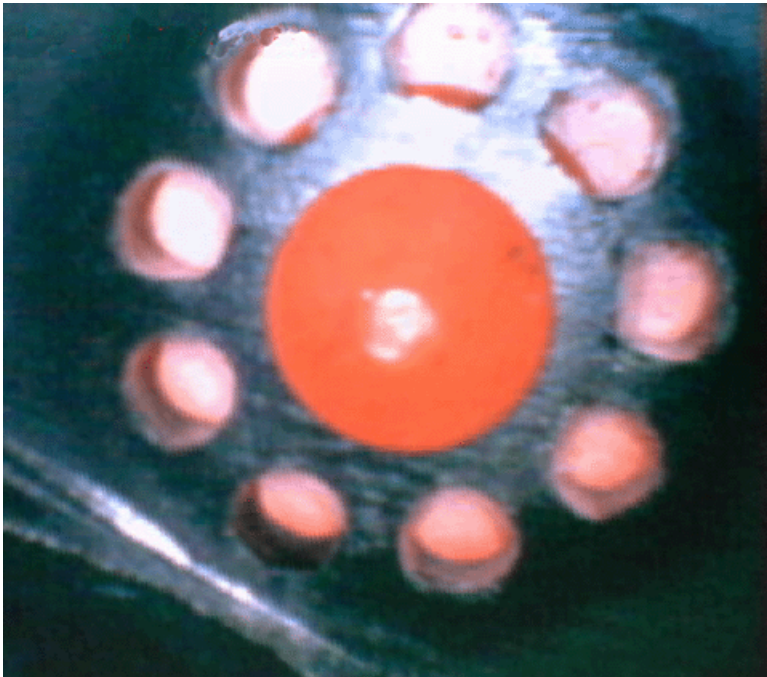
Properly seated Non Return Valve.

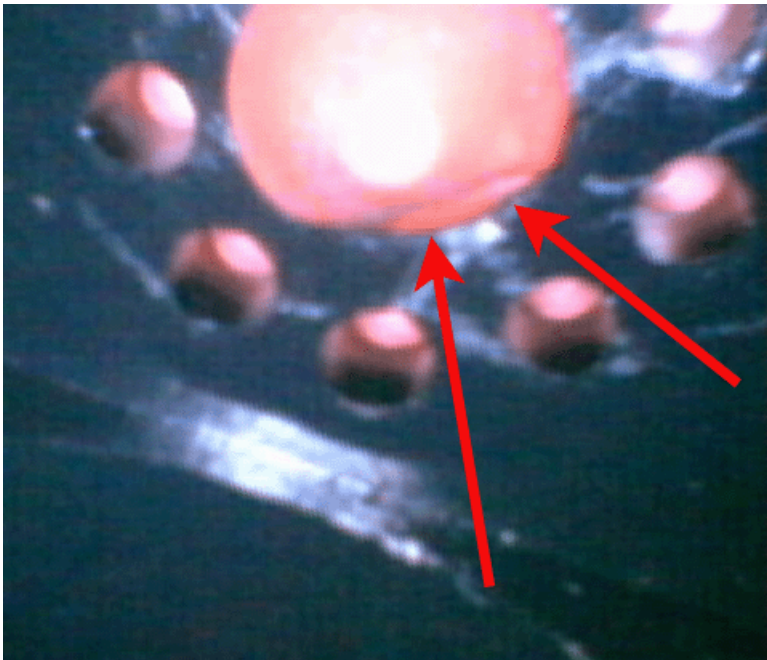
Improperly seated Non Return Valve.

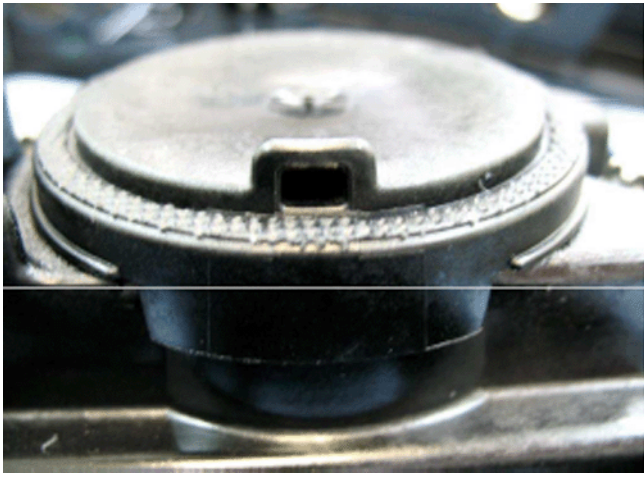
Check the PCV orifice for leaking oil or drawing vacuum at idle thru its external port. (The PCV orifice is an integral part of the camshaft cover). (See picture below).

If the PCV orifice external port is leaking oil or vacuum, replace the camshaft cover assembly.

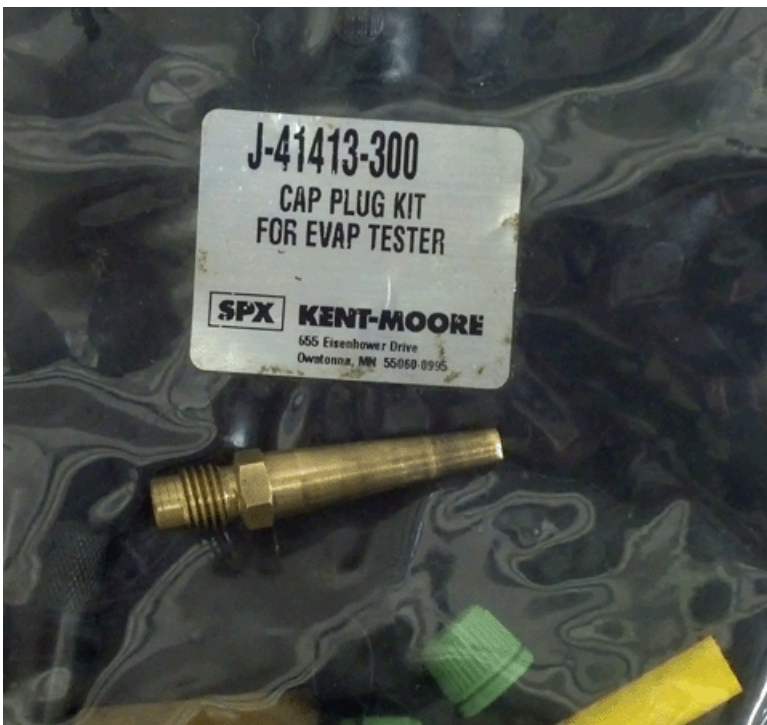
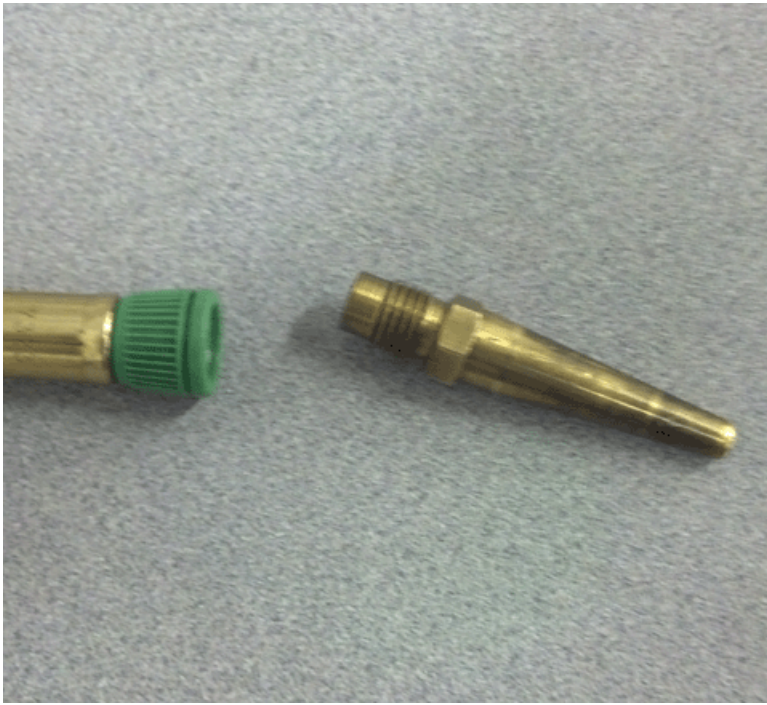
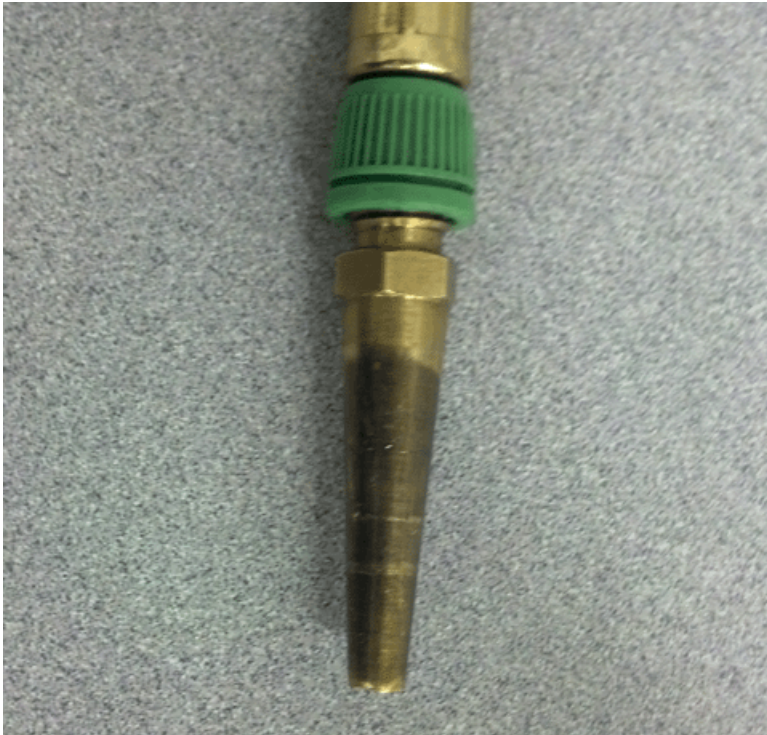
Record the crankcase pressure. (Normal crankcase pressure readings are between -11 & -18 inches of water in park at hot idle) / (ESST gage works best, see pictures below for connection of ESST at the engine oil dipstick hole in the camshaft cover).

**Note:** The connection must be made with the engine off. The engine is then started and the pressure reading is recorded.

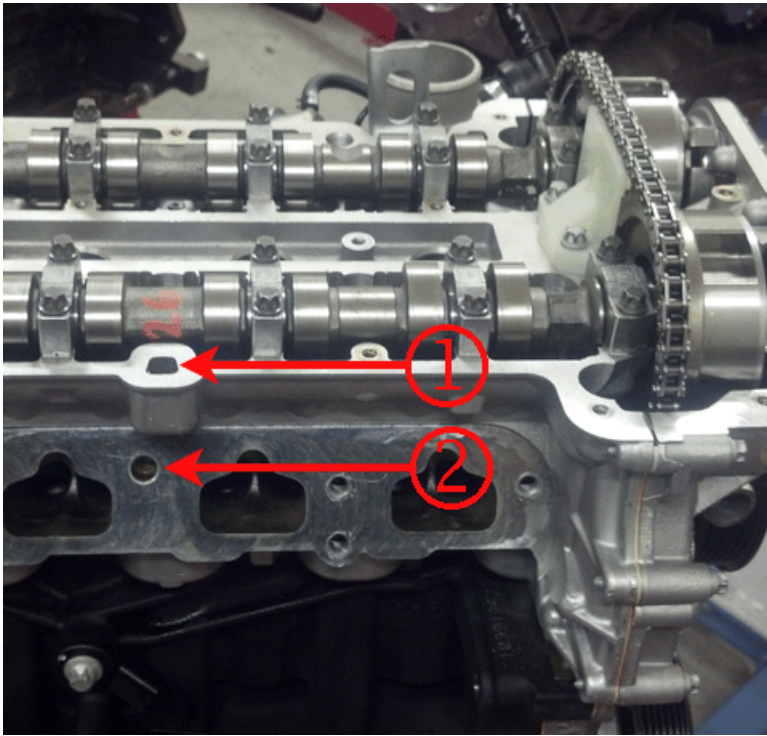
If the crankcase pressure is excessively negative, below -30 inches of water (-2 inches of HG / vacuum) the PCV port thru the cylinder head (Shown in the picture below between #1 and #2) may have a porosity issue causing intake vacuum to leak into the crankcase.

Plug the PCV port on the cylinder head at #2.

Fill the PCV port with a suitable liquid until full at #1.

Monitor the level of the liquid for fluid loss indicating porosity in the port.

If the fluid level drops, replace the cylinder head and retest for proper crankcase pressures.
