Service Bulletin

PRELIMINARY INFORMATION

Subject: EBCM Wheel Speed Sensor Diagnostic Aid for ABS Message -Click Or Ratchet Noise- Service Traction Message - Service Stabilitrak Message - Service Steering Message

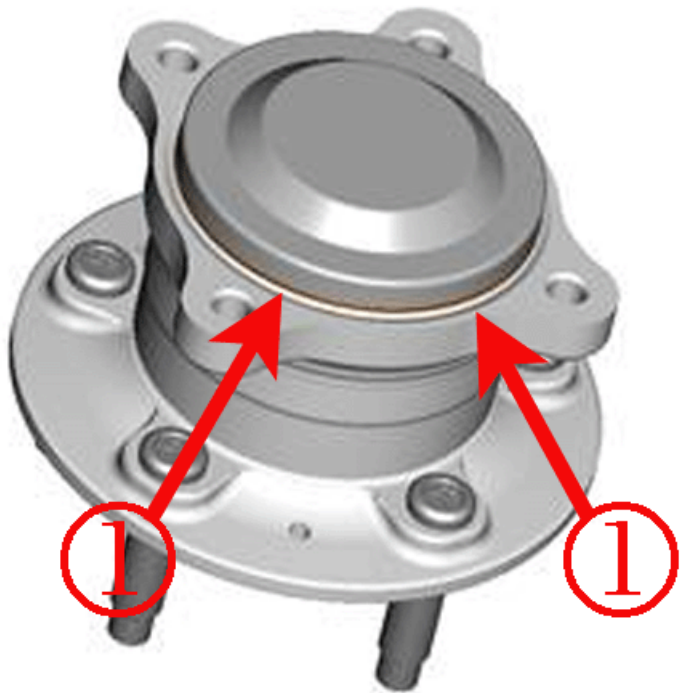
Note: NOTE: THIS INFORMATION IS NOT APPLICABLE TO CAPPED WHEEL BEARINGS.

(1.) Capped Wheel Bearing

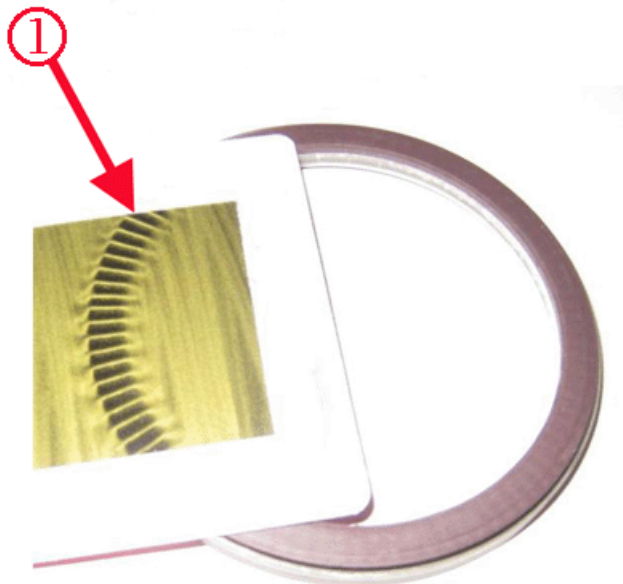
(1.) Wheel Speed Sensor

Magnetic Encoder Ring - North and South Poles are shown

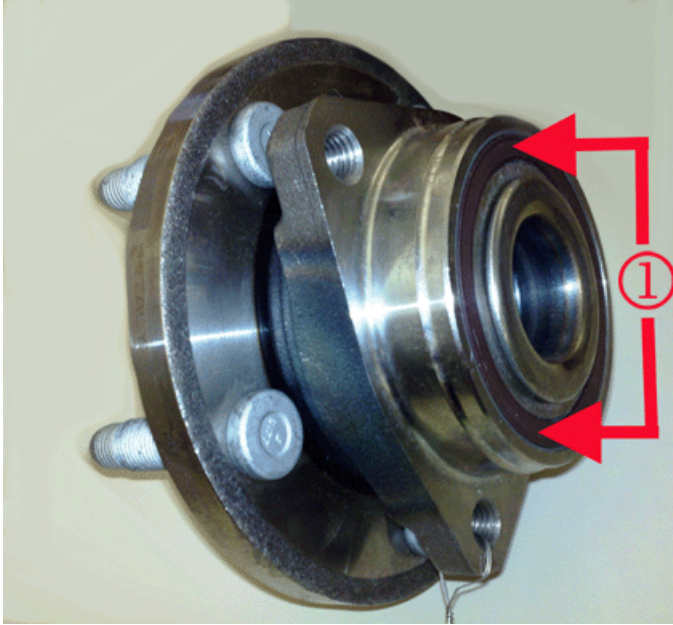
New Bearing Design.

(1.) Magnetic Encoder Ring

Some new model vehicles today have begun to use a different type of wheel speed sensor encoder ring or tone wheel. Instead of a traditional mechanical type tooth tone wheel, the wheel speed sensor tone wheel is now made of a magnetized nitrile rubber ring, typically brown in color. This magnetic encoder consists of multiple North and South Pole pairs surrounding the outer circumference. When this magnetic encoder ring rotates and passes by the wheel speed sensor head; it generates a sign wave in the wheel speed sensor. The wheel speed sensor converts an analog signal to a digital square wave, and typical digital signal values switch between 7mA (Low) and 14mA (High) DC current.

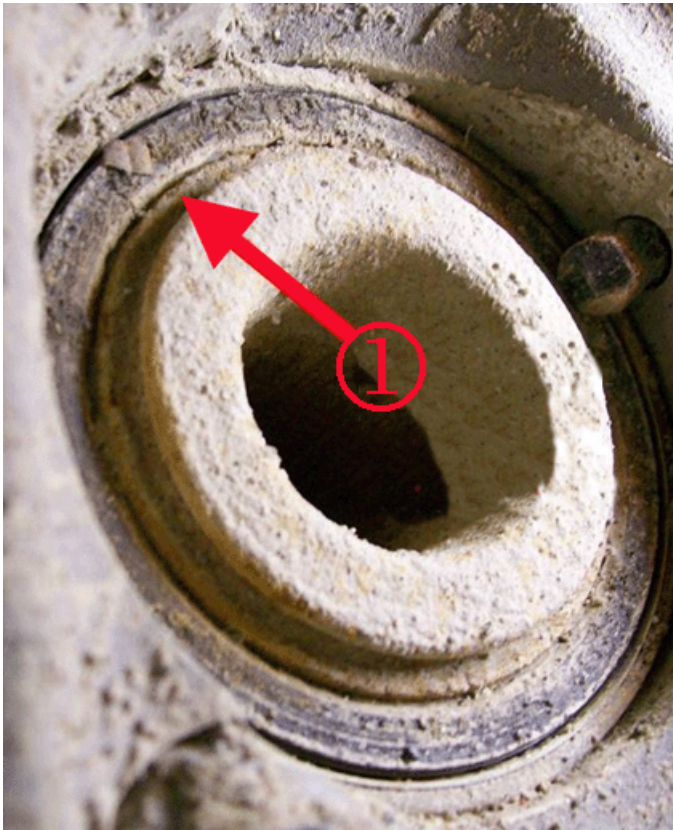
BEFORE CLEANING

These conditions may be caused by single or multiple pieces of ferrous metallic debris stuck to the wheel speed sensor magnetic encoder ring. This magnetic encoder ring is now part of the inboard bearing hub assembly.

(1.) Sample Debris

1. Based on the specific EBCM module Wheel Speed Sensor DTC code; inspect the appropriate corner magnetic encoder ring for possible debris.
 - C0035 Left Front Corner
 - C0040 Right Front Corner
 - C0045 Left Rear Corner
 - C0050 Right Rear Corner

2. If debris is found, perform the following cleaning recommendations.

- 2.1. Gently using a dry nylon soft bristle brush, remove the foreign debris off the magnetic encoder ring. If debris was removed, proceed to step 3.
- 2.2. If debris still remains, wash the encoder ring using a mild soap detergent and wipe dry.
