**Bulletin No.: PIC6001**

# Service Bulletin

Subject: Wind Noise From Front Of Vehicle While Driving

Models: 2014 Chevrolet Camaro

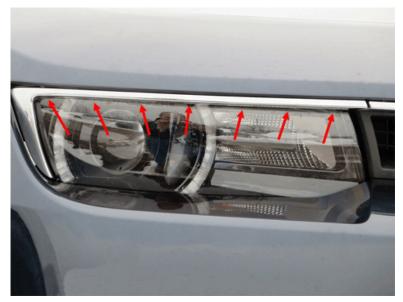
Through extensive testing on this issue, it has been confirmed that this whistle noise may be caused by wind rushing over the various gaps around the headlamp capsules of the vehicle. This issue may produce a higher pitched wind noise when the car is driven at speeds of 40 MPH and greater. It may even be difficult for every technician to hear this noise. Depending on the direction and severity of the wind, as well as the direction and pitch of the vehicle, this noise may come and go completely, or this may simply change in volume. To narrow this concern down, dealership technicians are to apply 2" wide masking tape along the upper edge of both headlamp assemblies, make sure that the tape covers the gap between the headlamp capsules and the adjacent chrome trim directly above it. Test drive the vehicle to confirm that the noise has been eliminated. It has been found that either headlamp may contribute to this noise.

Area of Concern: Most cases have been found to be caused by the gap between the headlamp capsule and the chrome trim around the top edge of the headlamp capsules. This gap has been pointed out using the red arrows in the photo below.
