Service Bulletin

PRELIMINARY INFORMATION

Subject: SES MIL And/Or No Crank (Inspect Engine Harness Chaffing At Vacuum Pump Pulley)

Models: 2014 Chevrolet Silverado 1500
2014 GMC Sierra 1500
With Engine 5.3L (RPO L83) or 6.2L (RPO L86)

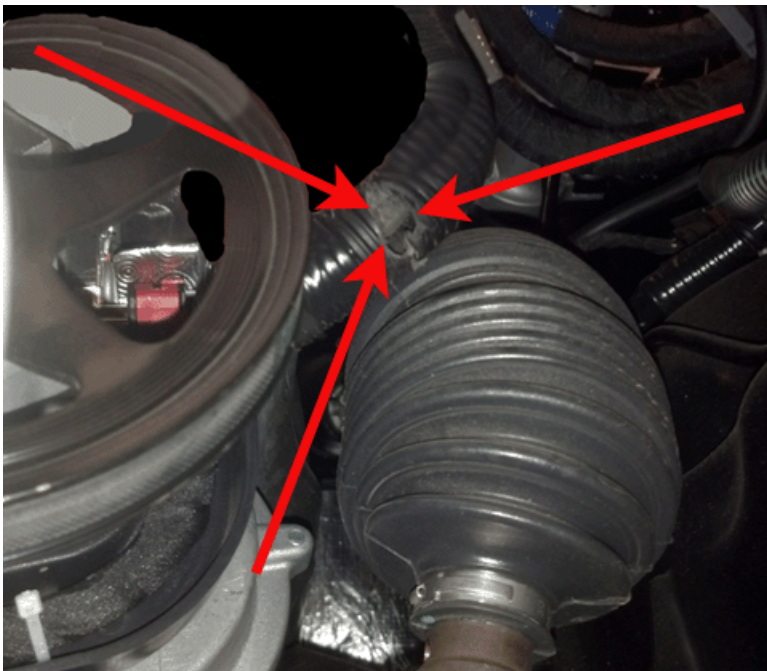
Some owners may comment on a SES MIL with any of the DTC's listed below and/or a no crank issue caused by the "STRTR" fuse 11 (F11UA) in the UBEC for being open. These issues could be caused by the engine harness rubbing on the engine vacuum pump pulley, as shown below.

Any combination of the following DTCs may be found in the ECM: P06DA, P06DB, P06DC, P0325, P0327, P0328, P0330, P0332, P0333, P0340, P0341, P0331, P0336, P0011, P0010, P2088, and/or P2089

Repair any damaged circuits, and resecure the harness away from the pulley to prevent the issue from reoccurring.
