Service Bulletin

Subject: Oil Canning Or Pop Noise In Rear Seat Area

Models: 2010 - 2014 Chevrolet Camaro

Coupe Models Only

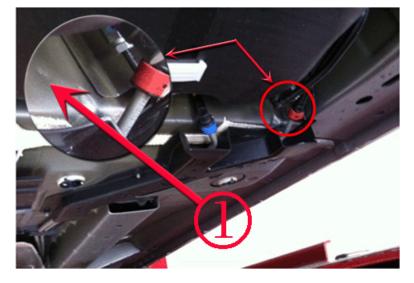
Some customers may comment on an oil-canning or popping noise coming from the rear seat foot well area while driving. This condition is most noticeable on rough uneven roads or when turning into a driveway. This condition may be caused by "oil canning" of the sheet metal in front of the rear seat lower cushion.

- 1. Raise the vehicle.
- 2. Using a ball-peen hammer or similar tool, dimple the panel as shown below.
- 3. Apply a butyl patch on the panel, being sure to also cover the dimpled surface with the patch.
